City of Ft. Wright – Civic Club Property Conditions Assessment

June 19, 2024

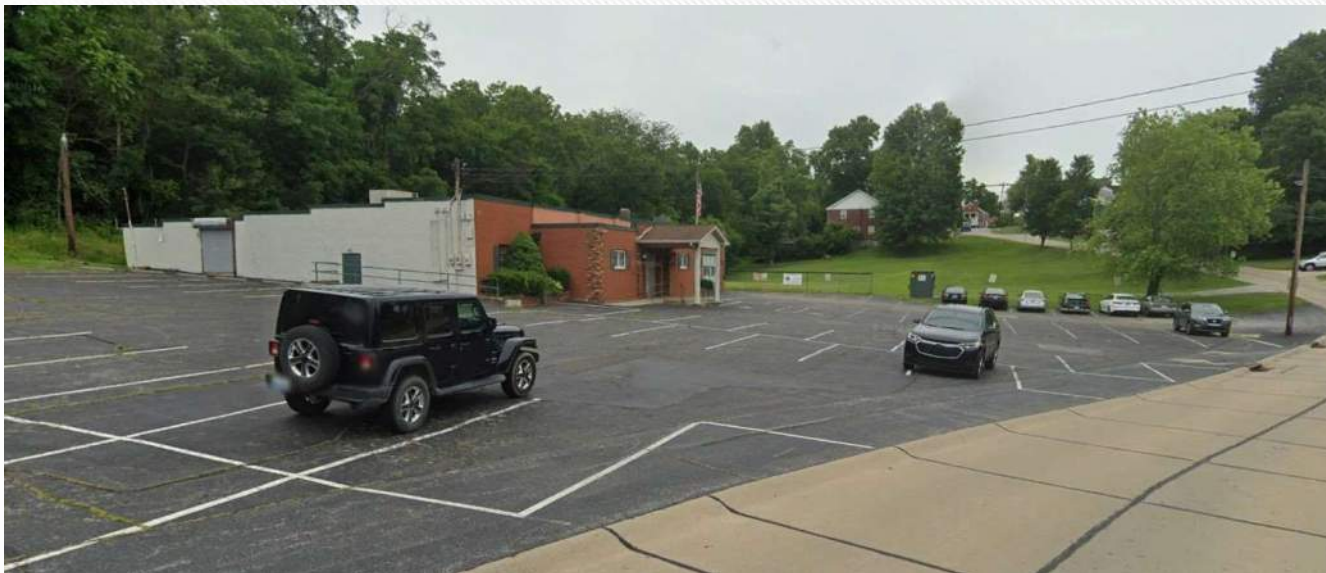
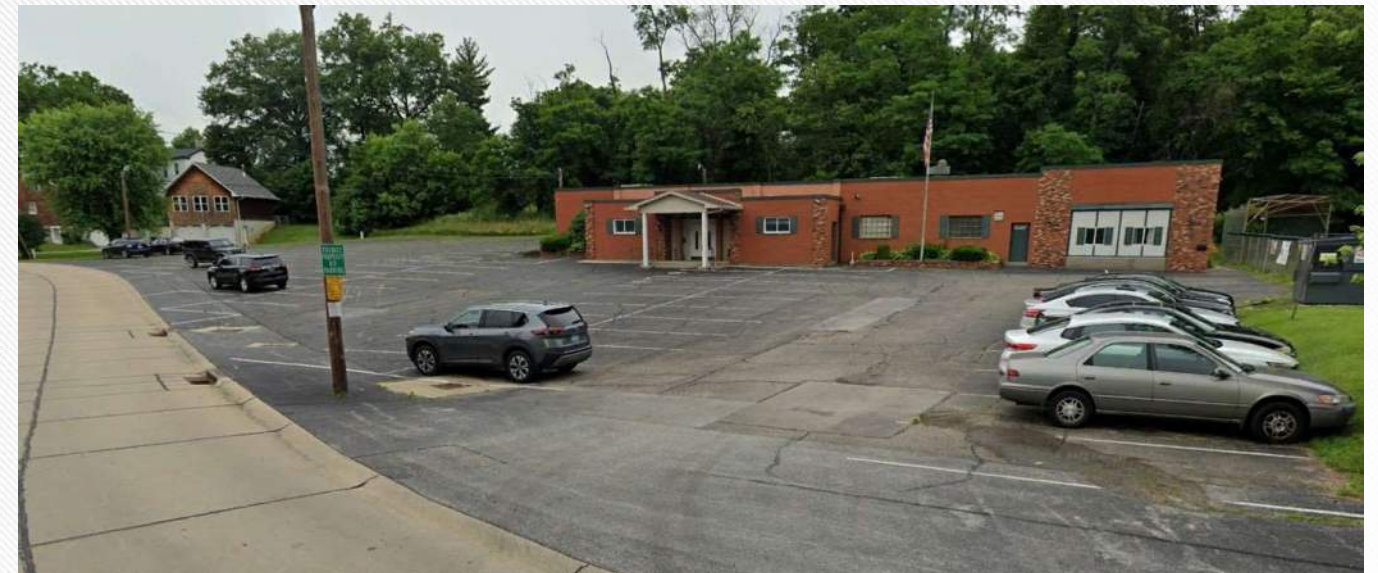
- Missing building and roadside signage and site entry designation providing direction to visitor parking, deliveries (IBC 2018 1111.1 & 1111.2).

- Asphalt pavement is in fair to poor condition and has slight to moderate cracks in 65-75% of overall surface.

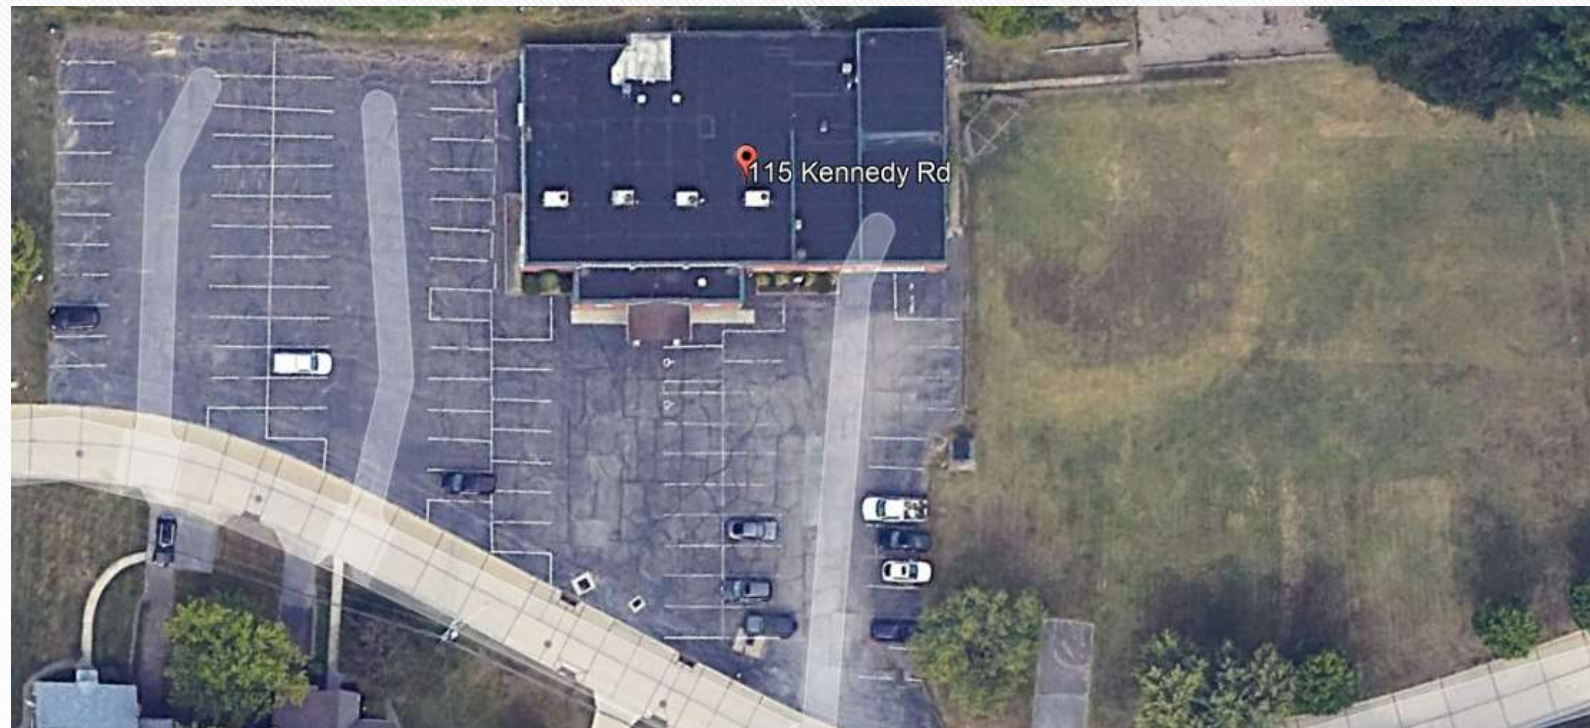
- Crossing pedestrian traffic from vehicular drive aisle and public parking does not appear to be intuitive and is potentially dangerous.
- Offstreet parking is approached from Southeast Kennedy Road entrances, Entries do not have clear directional markings or signage. Visitor parking is at a 90 degree angles and pavement stripes are worn. There are two designated handicapped parking spaces. Refer to Kenton County Polling Place Deficiency report for additional information on Federal Guidelines for ADA Parking Requirements.

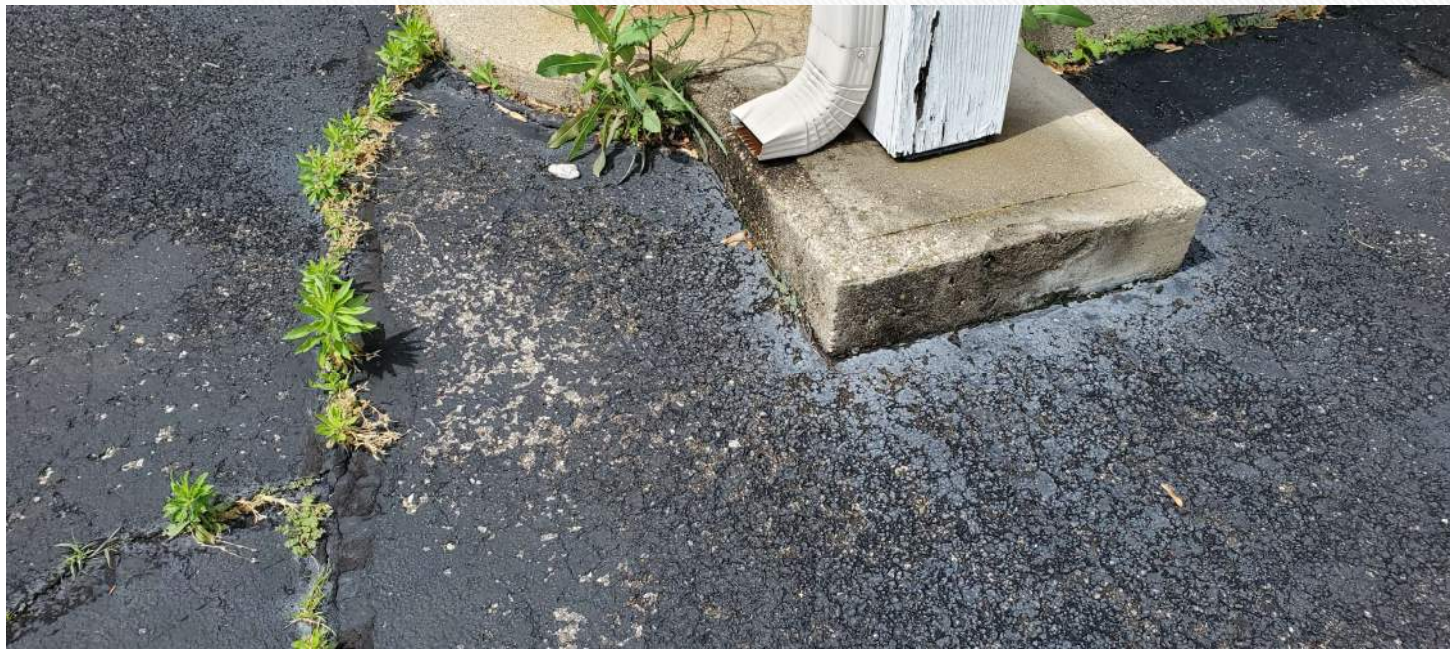
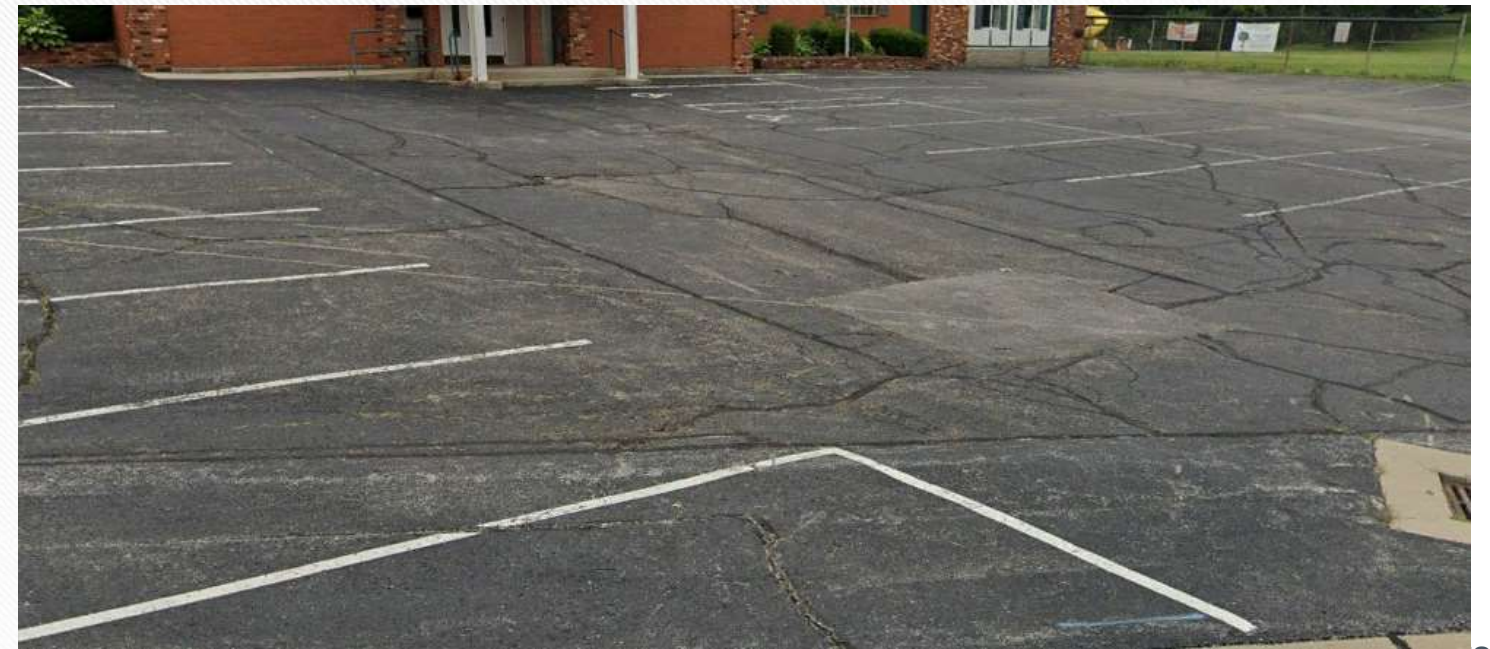
- Asphalt parking striping is worn, no longer clearly visible.
- Stormwater splashes to pavement. Frozen, icy pavement in wintertime conditions is a pedestrian and employee hazard.
- Concrete is in average condition, flatwork and islands have spalling and chipped/broken corners.
- Major regrading and pavement replacement will be required to achieve the appropriate number of spaces and maximum slope requirements for ADA accessible parking. Required slopes will be very difficult to achieve based on existing pavement slopes. This will likely result in the reduction of the number of parking spaces
- Front entry features will need to be completely redone in order to provide proper accessibility.

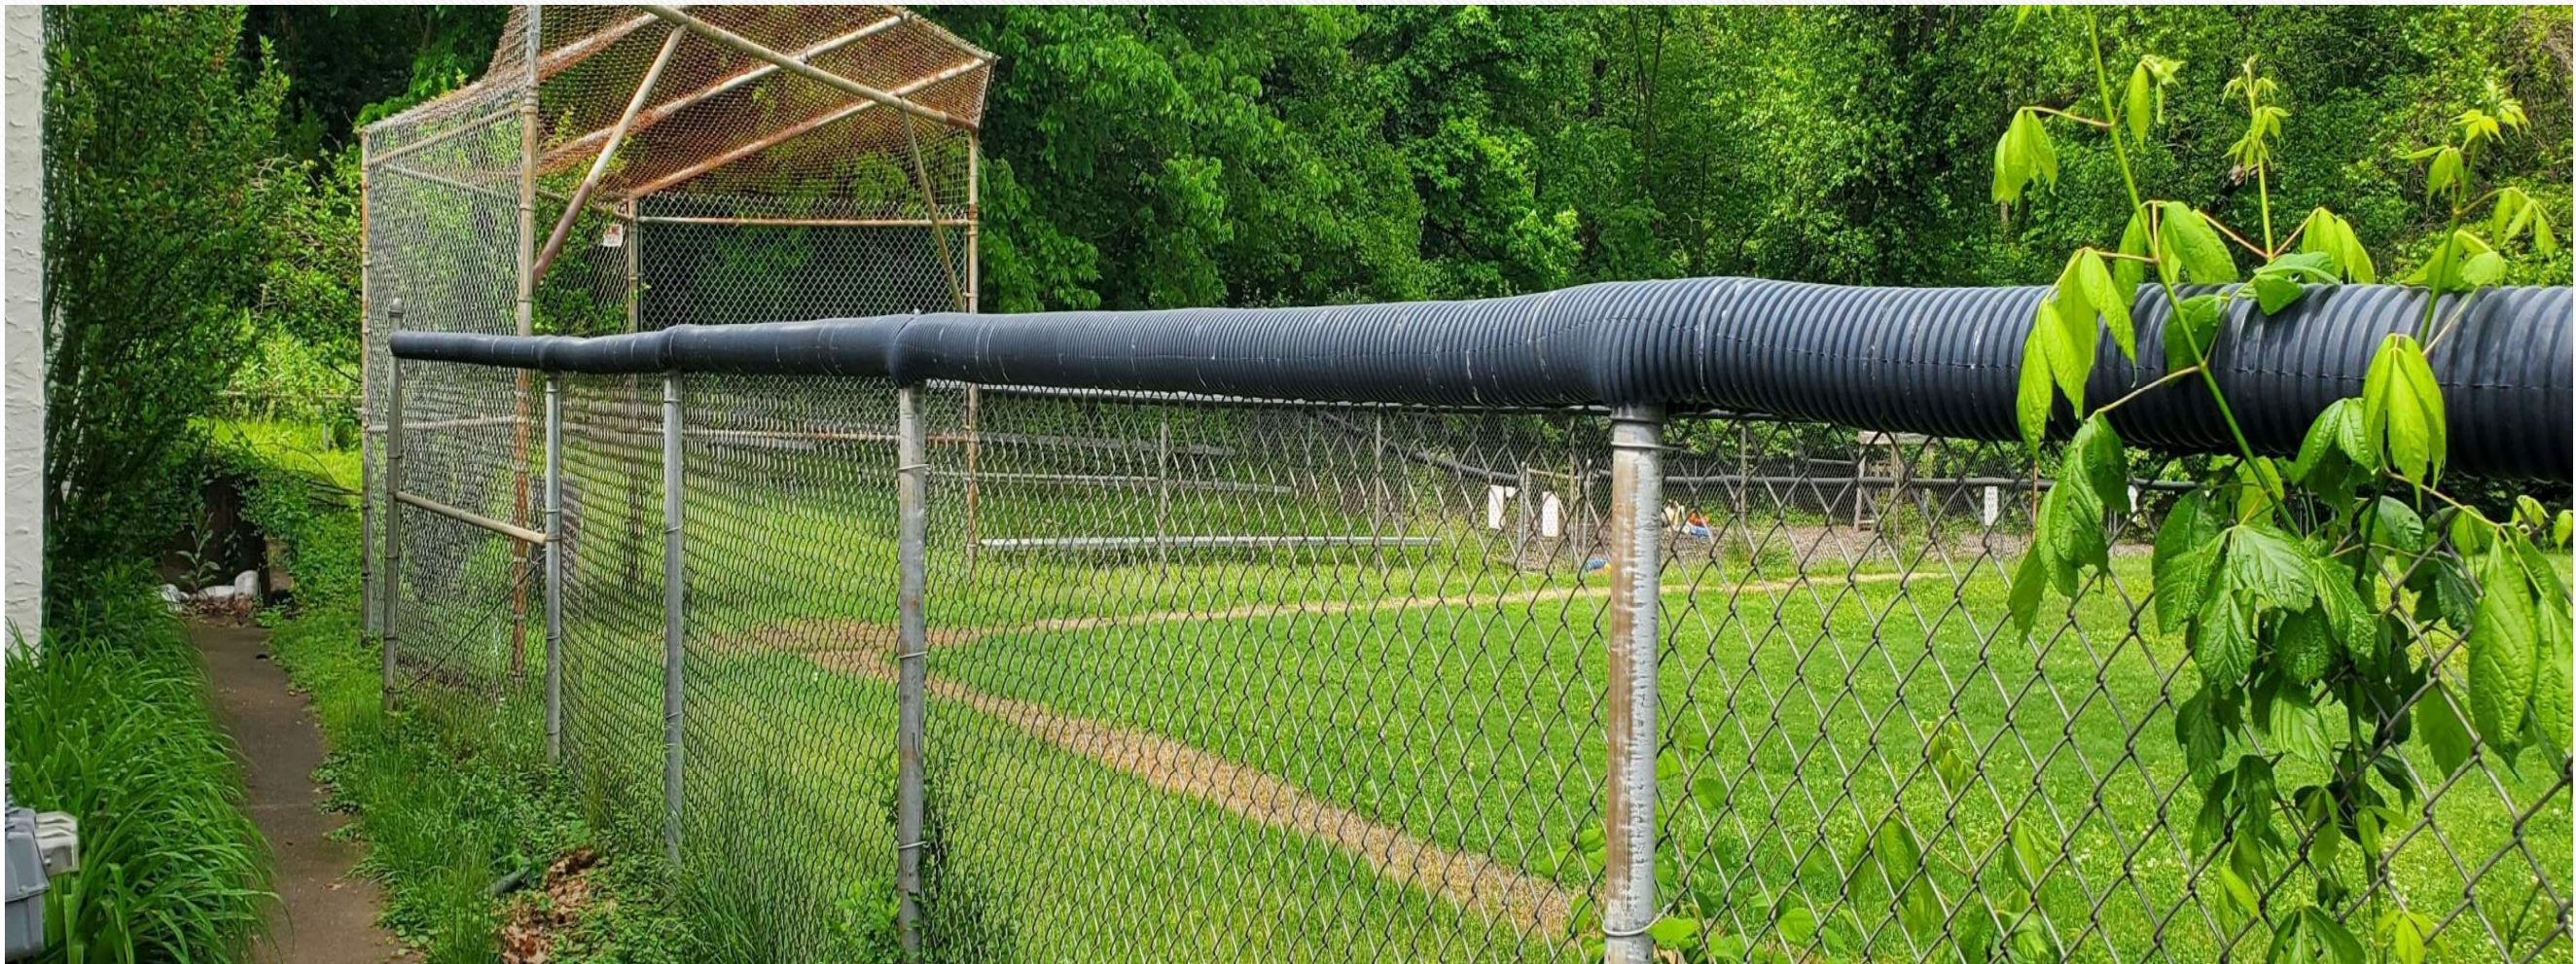
- Vacant Baseball Field occupies roughly 1/3rd of the site requiring periodic lawn maintenance. This space has good potential for a developed neighborhood amenity.

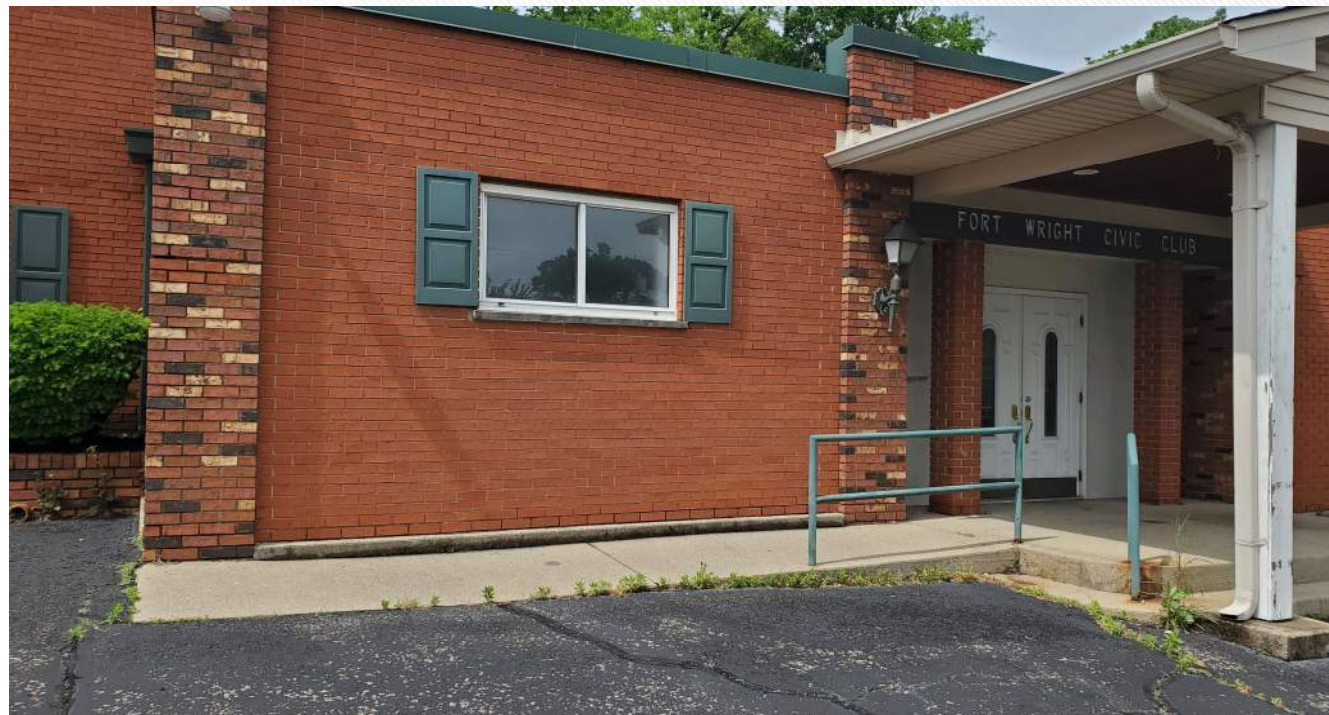
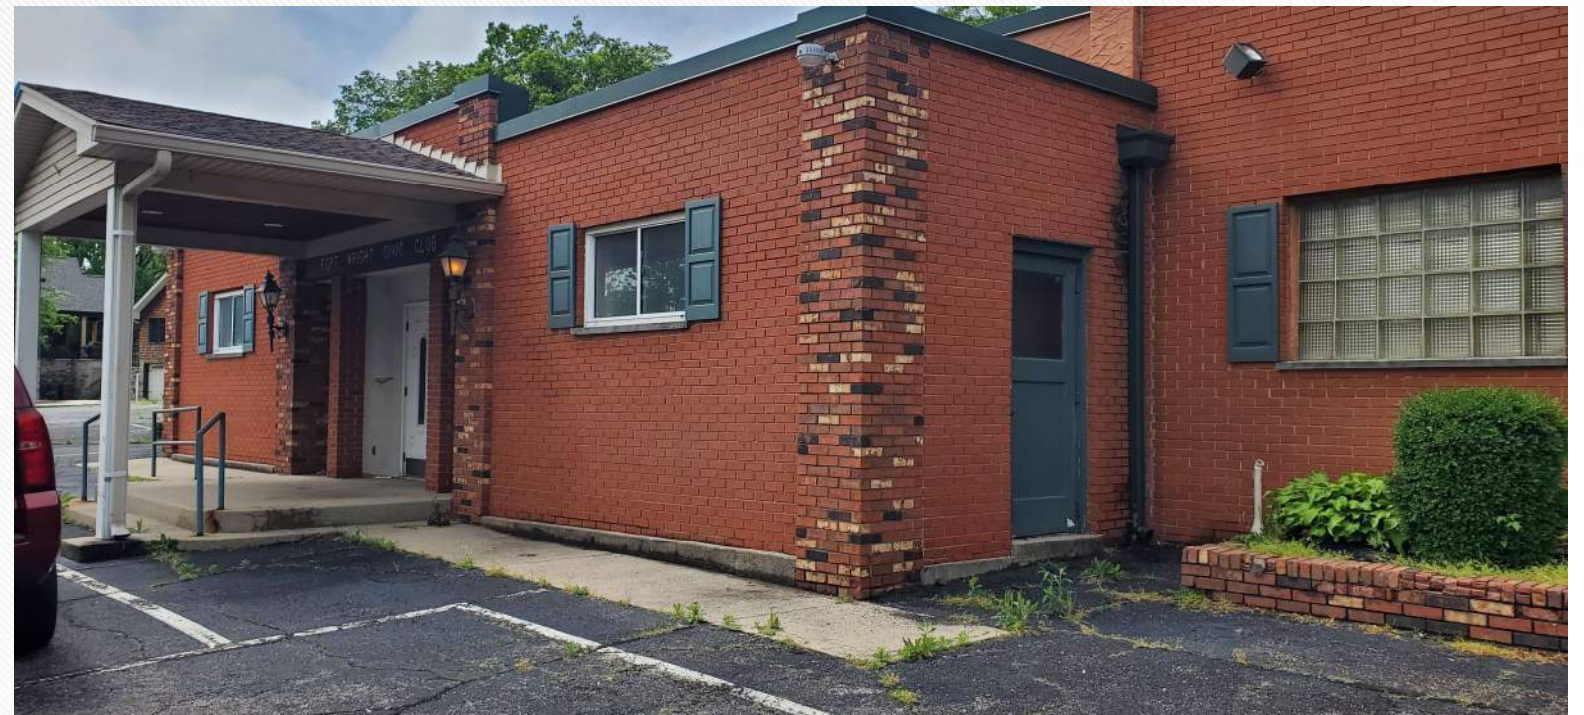
- Multiple exterior field brick are broken, tuckpointing is required in select areas. Some chips or cracks in the foundation were observed at the perimeter
- Most exterior windows and entry doors appear to be original, and do not meet current SHGC and air infiltration ratings.
- Most exit and egress doors has a non-ADA step down to asphalt pavement without a sidewalk leading to a public way. Parking Lot will need to be regraded in order to meet full doorway accessibility requirements.

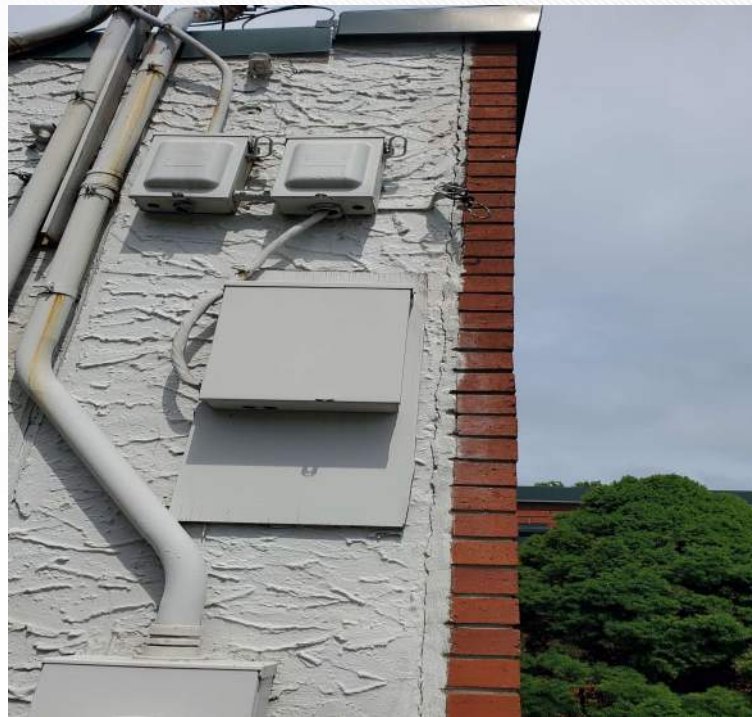
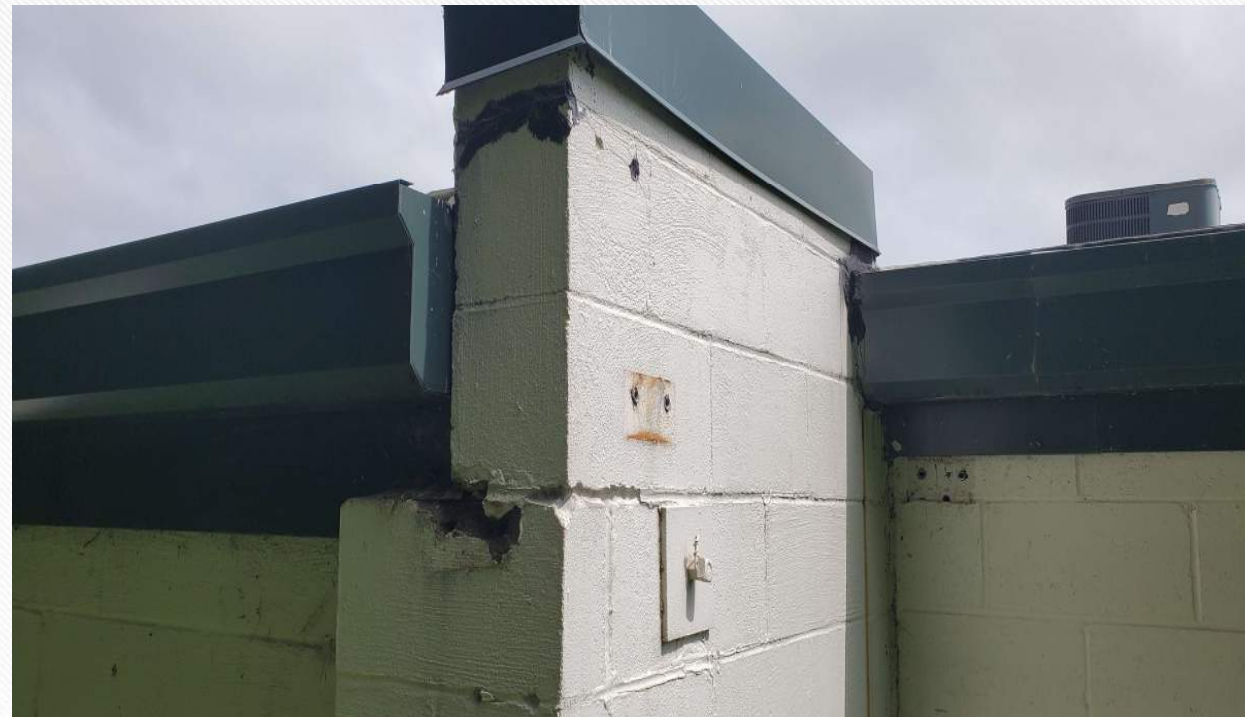
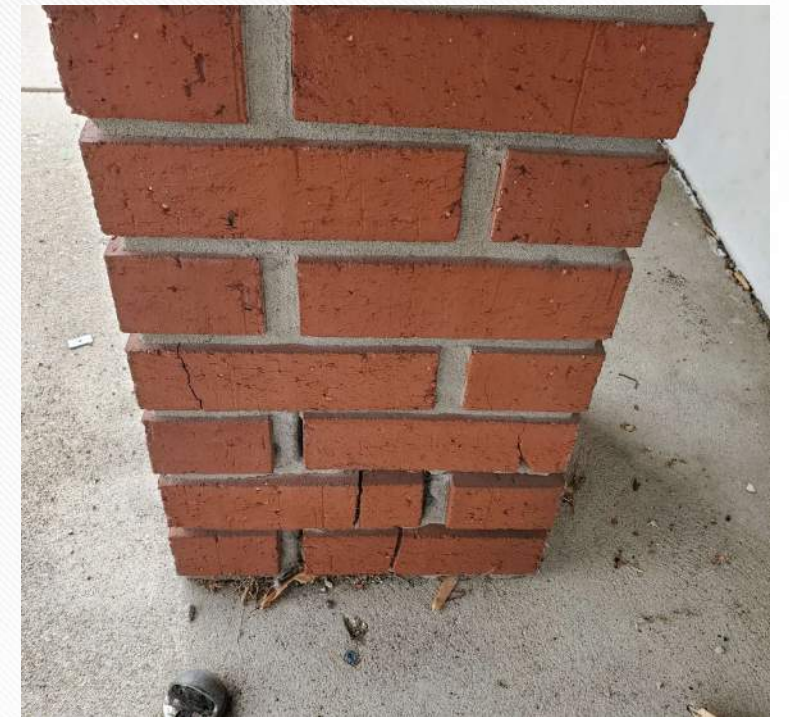
- Brick veneer appears to be pulling away from the CMU block in some areas. Water infiltration from forming gaps with freeze-thaw will accelerate deterioration of the brick ties.
- Exposed CMU block has stair-step cracking forming and the metal coping needs new sealant.

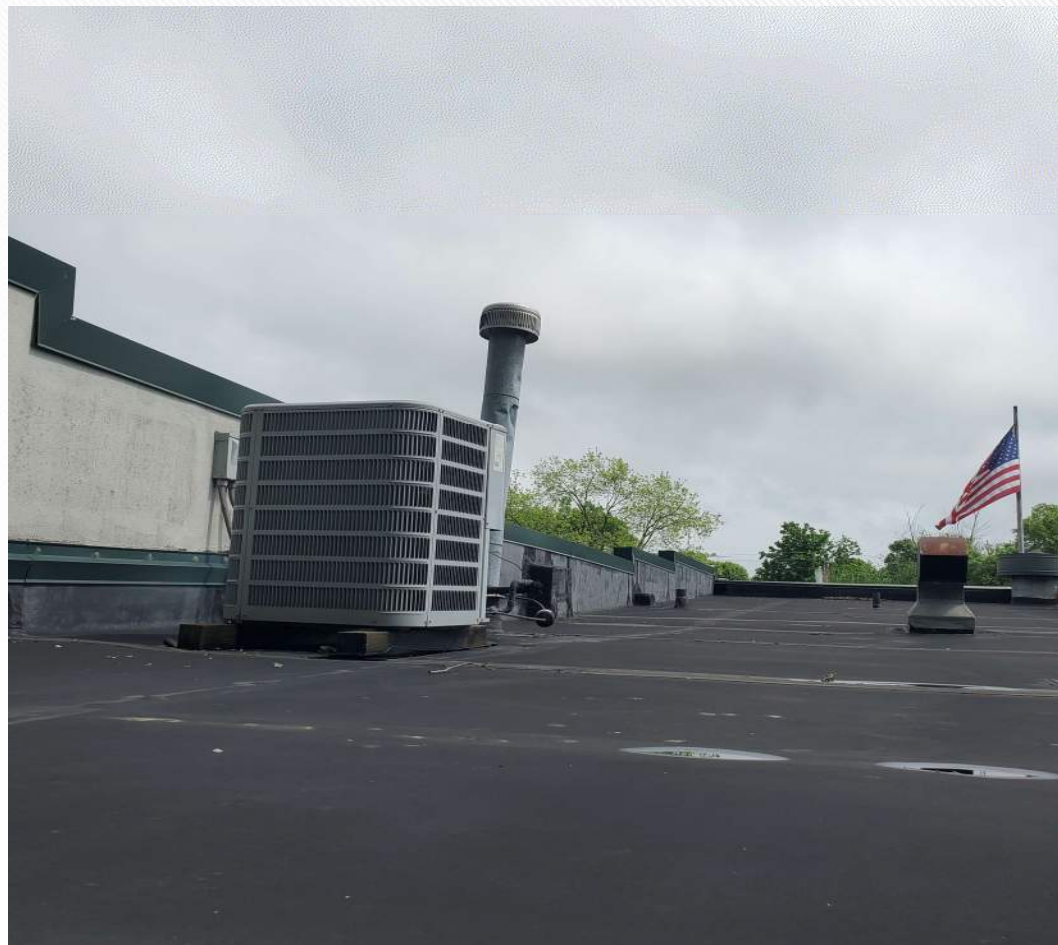
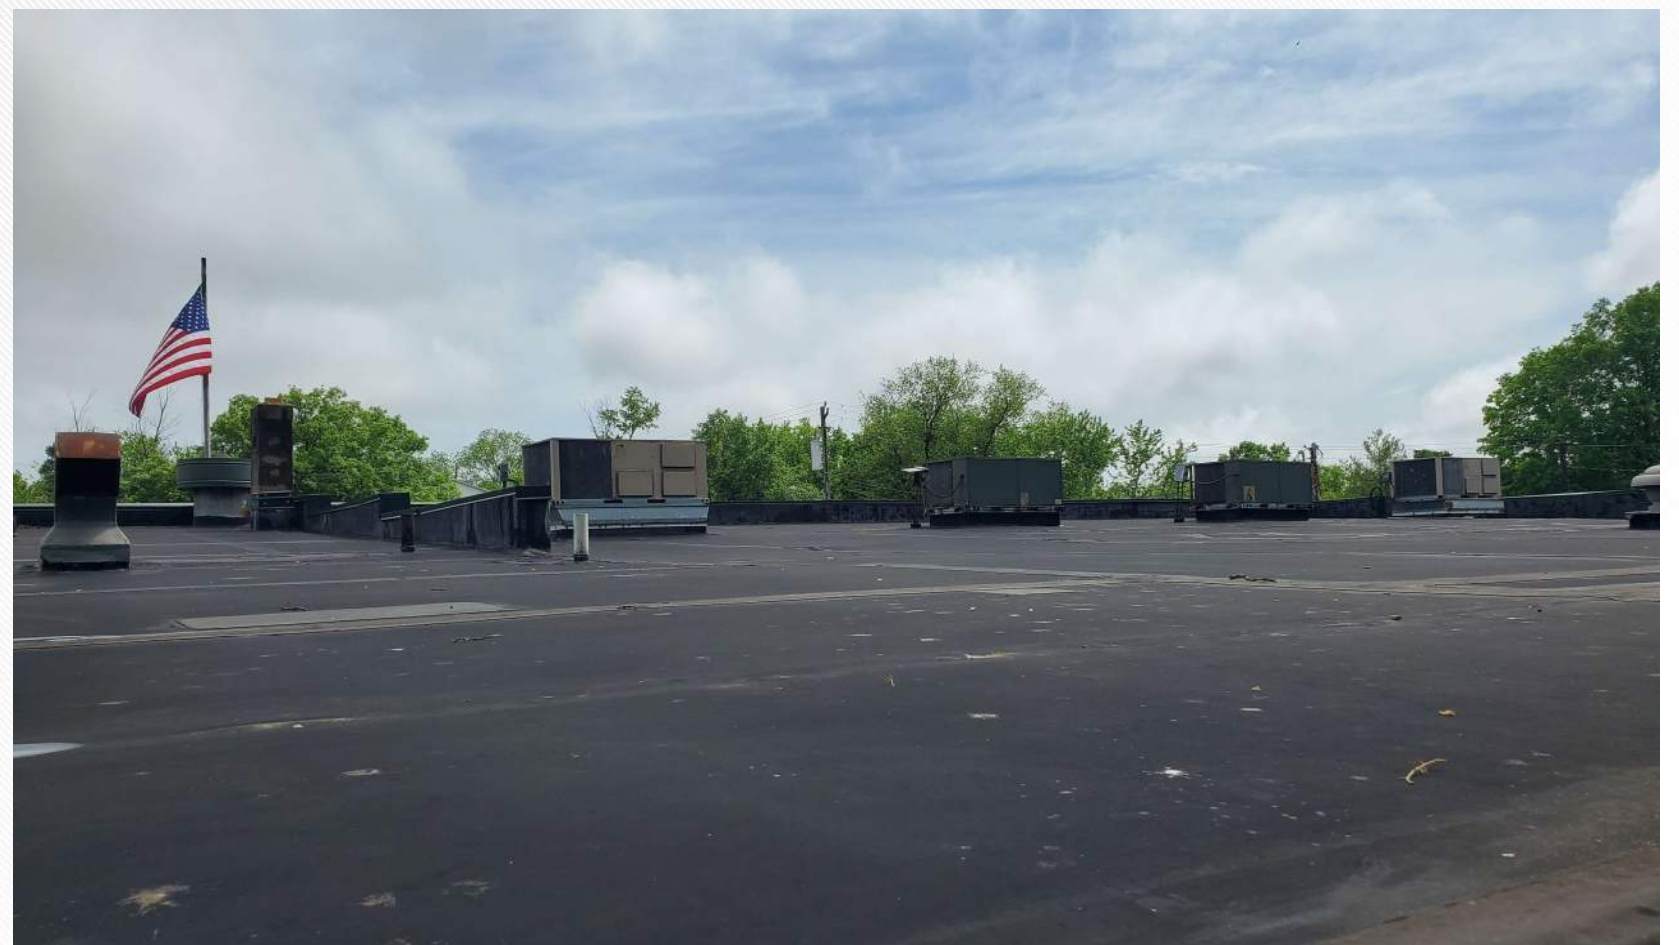
- EPDM roofing is outside of its warranty period, nearing the end of its useful life, roof water leakage was observed in the inside and roofing needs to be patched or replaced.

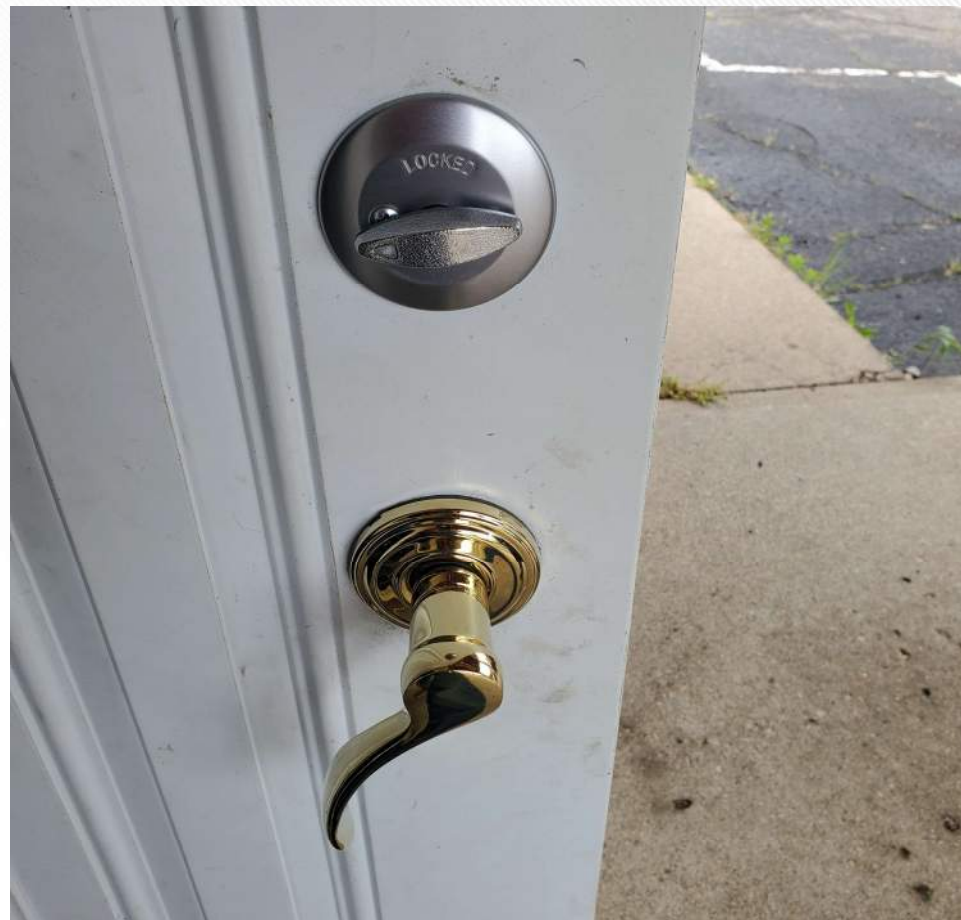
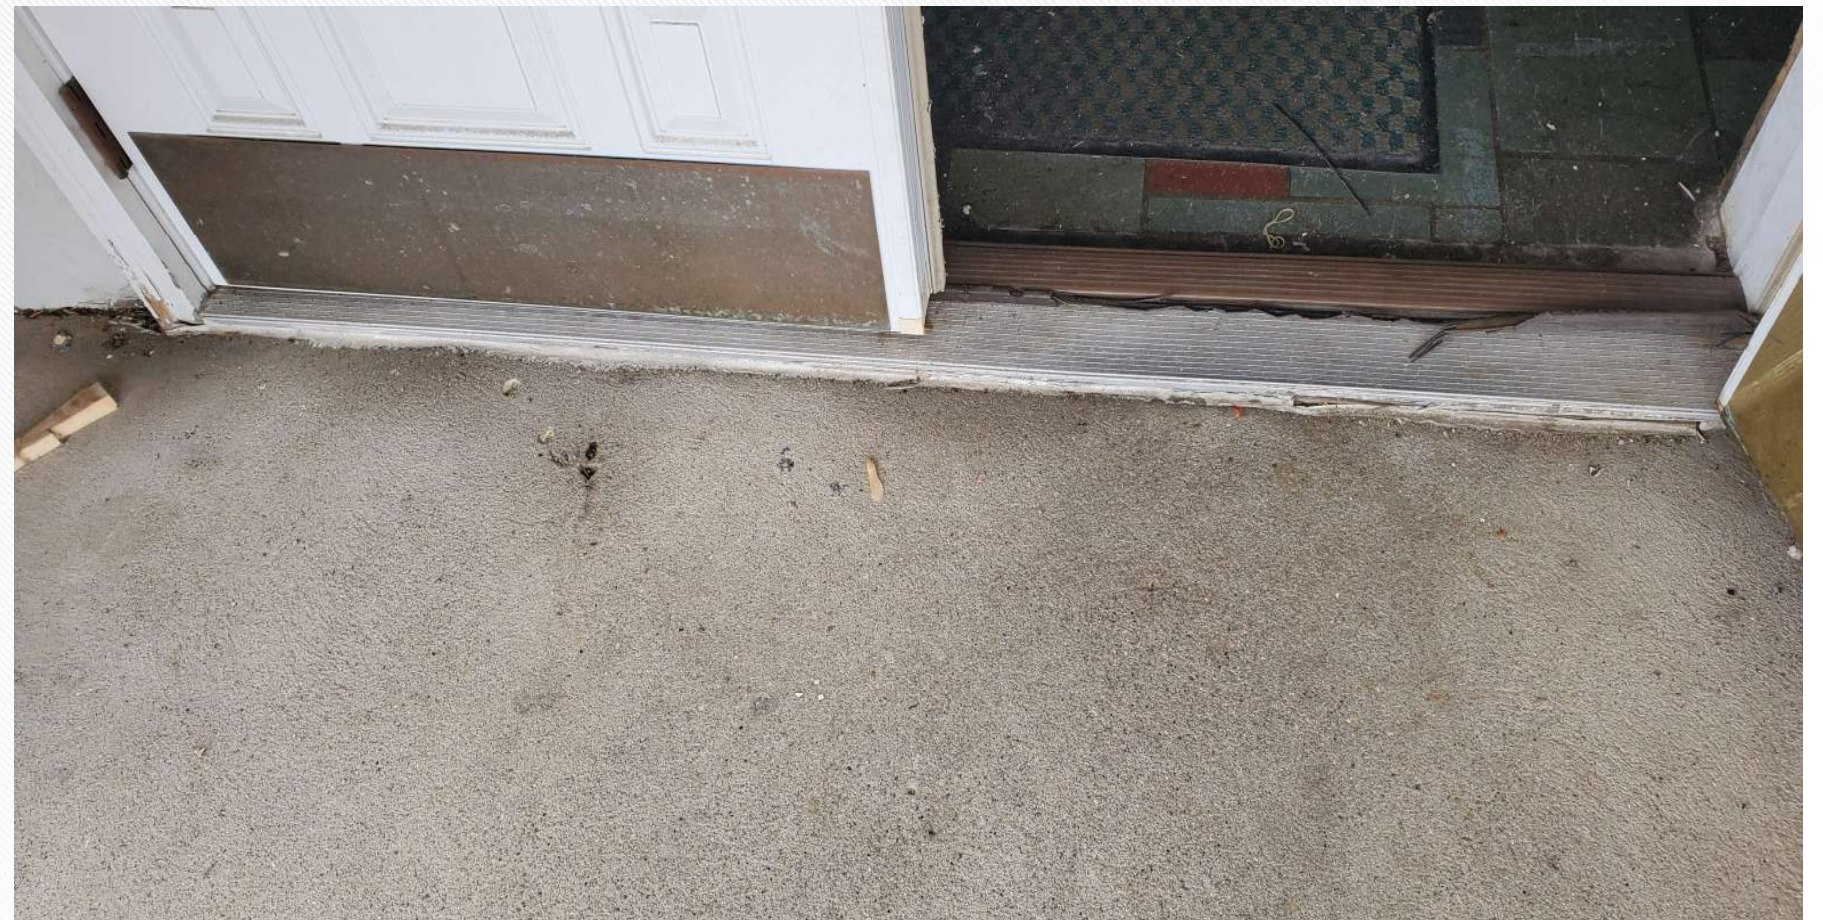
- Entry Doors do not have required Panic Hardware and have a thumbturn lock without signage indicating it to remain unlocked.
- Entry Door has non-compliant ADA threshold with lip exceeding 1/2" in height.

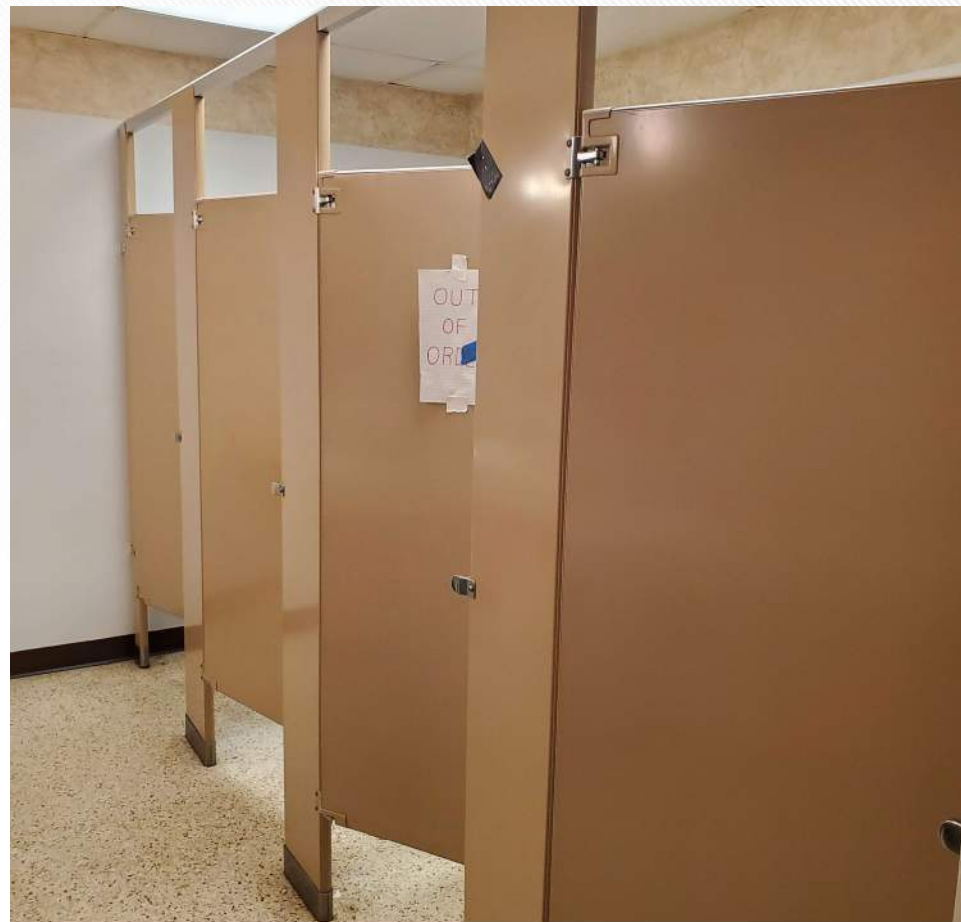
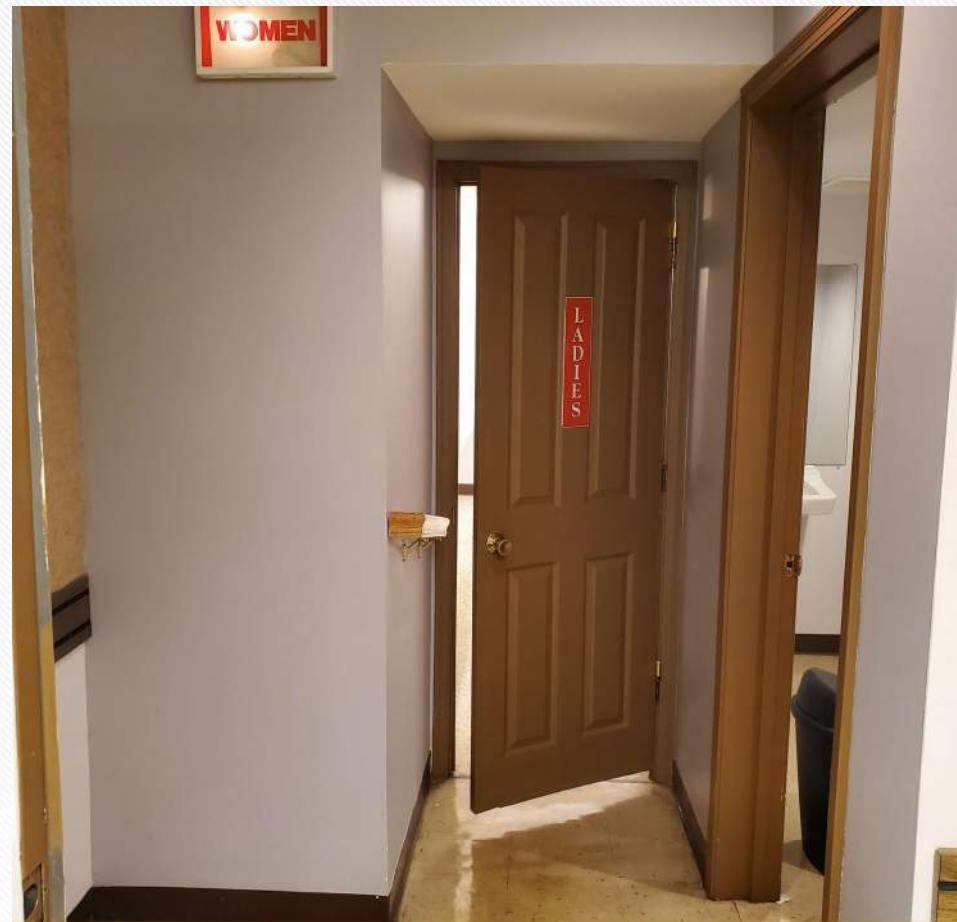
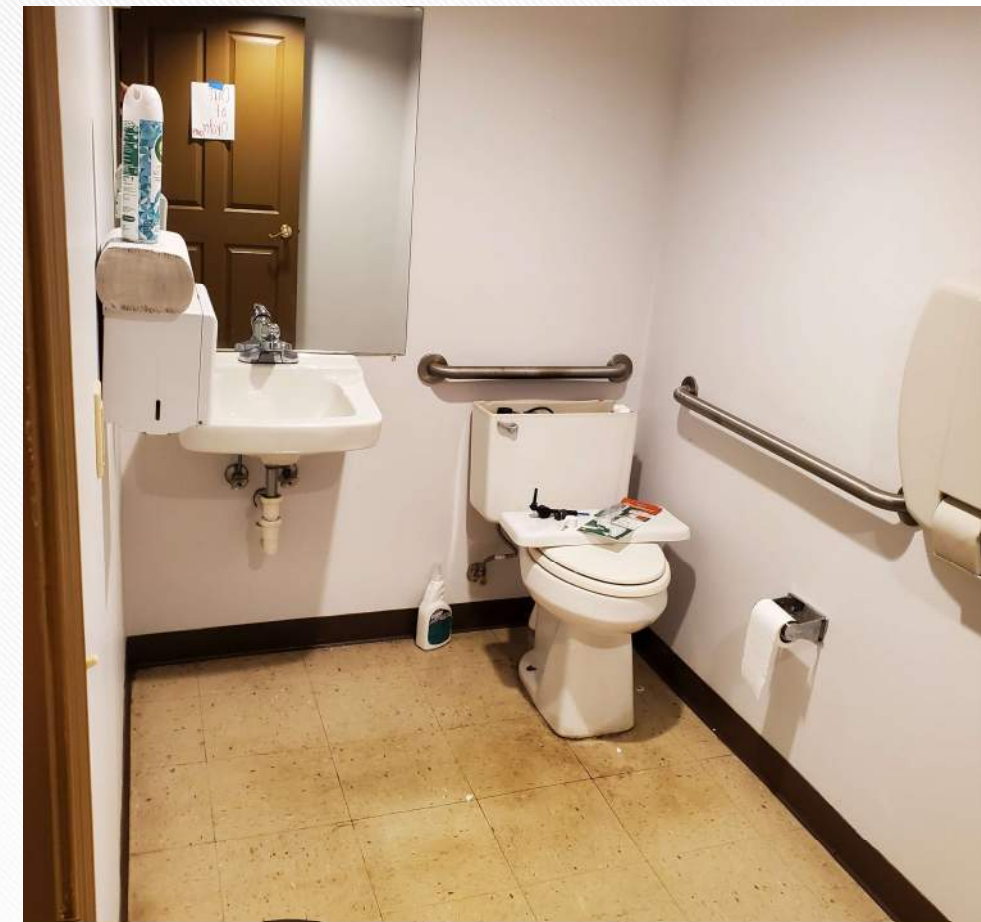
- Toilet Rooms do not have required Push/Pull 12"/18" door latch clearances and 66" clear wheelchair turning radiuses.
- Wall mounted fixtures have exposed piping and are not mounted at the correct height.
- Many toilets are not in service and in disrepair.

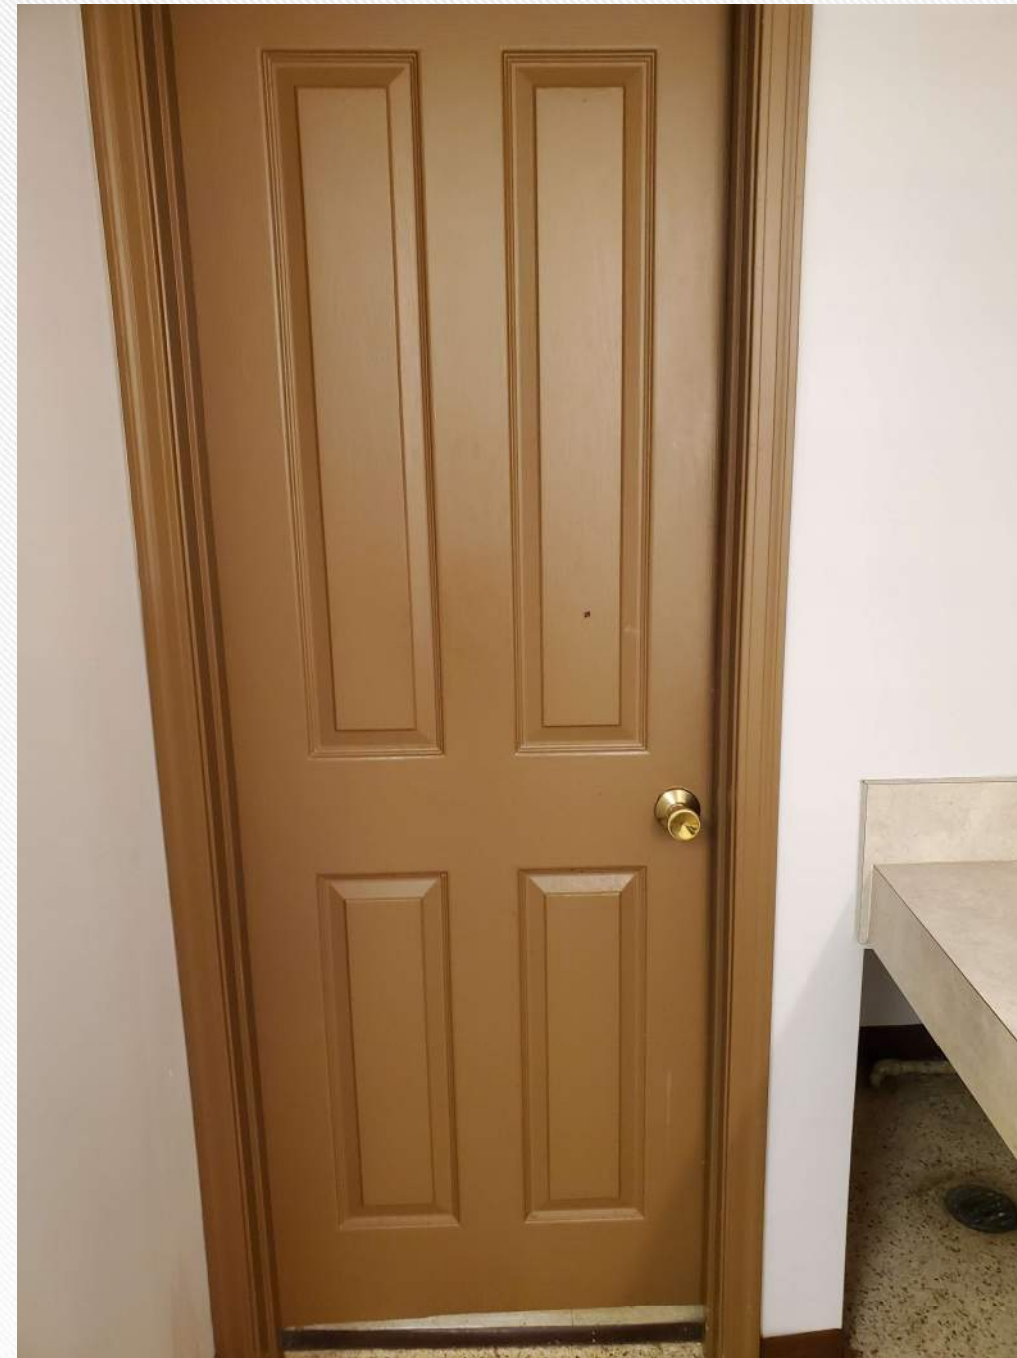
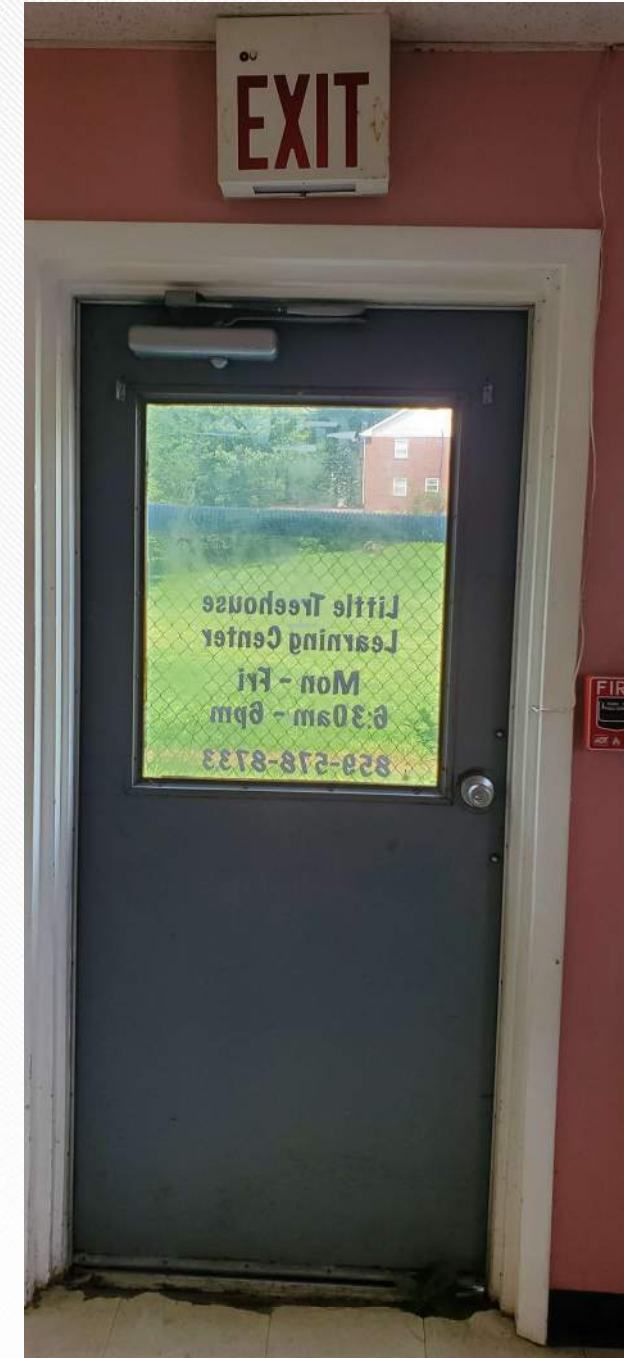
- Interior doors are residential grade raised panel and knob pulls. Knob pulls are not acceptable for ADA egress and do not comply with ANSI A117.1 accessible door handles.
- Some are have cosmetic damage and are not sufficiently wide to meet 32" w. clear distance accessibility requirements.
