City of Ft. Wright – Civic Club Property Conditions Assessment

June 19, 2024

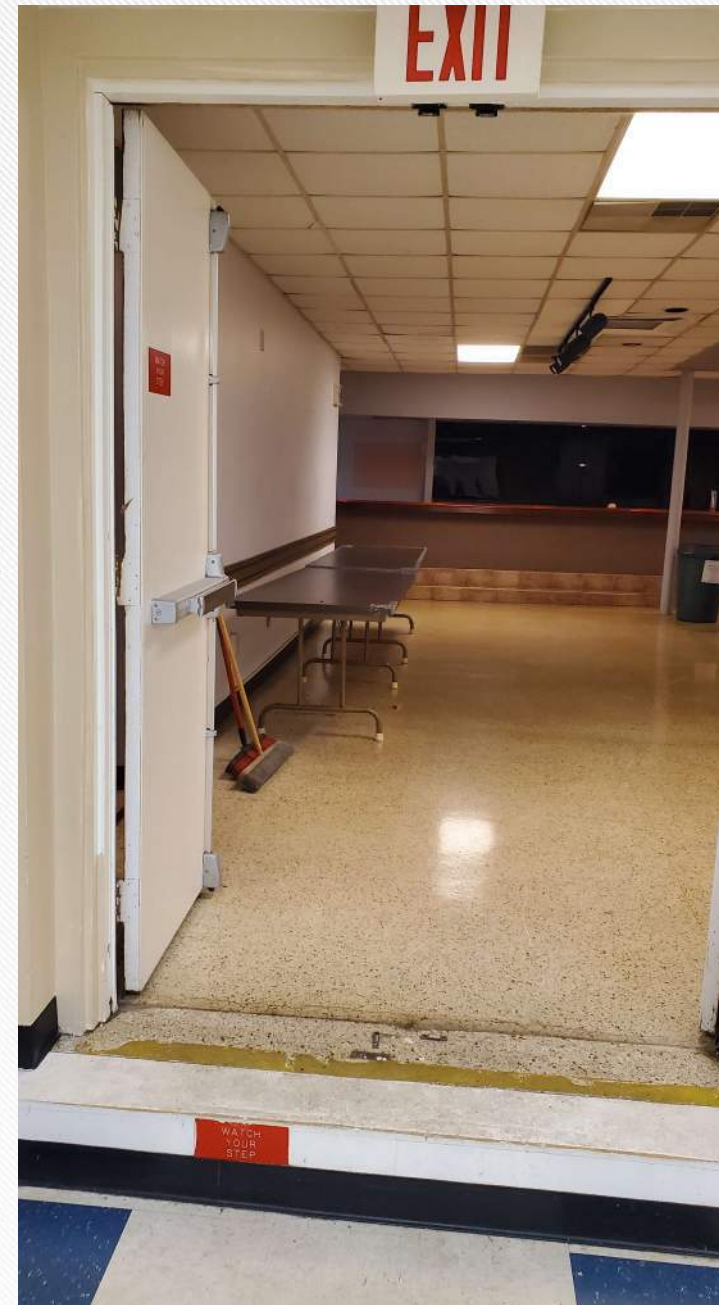
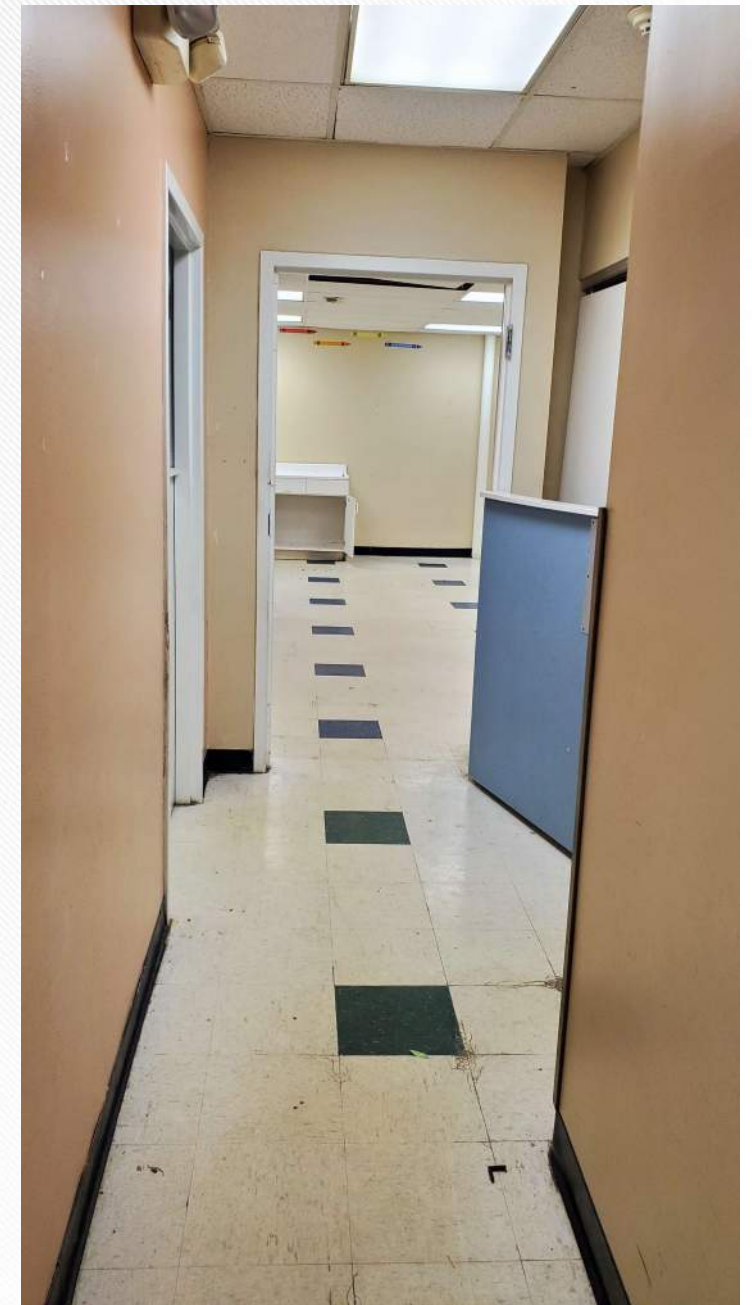
- Means of egress path of travel uses intervening rooms for exiting. This condition is not compliant with current building code requiring corridors leading directly to the exterior. (IBC 1016.2)
- Corridors leading to intervening rooms do not appear to be 1-Hour rated for B-Business Use, Non-Sprinkled buildings. (IBC Tbl. 1020.1)
- Room and spaces within the facility have ramps and steps not in compliance with a required ADA accessible route through the building. IBC 1102. (ANSI A117.1)

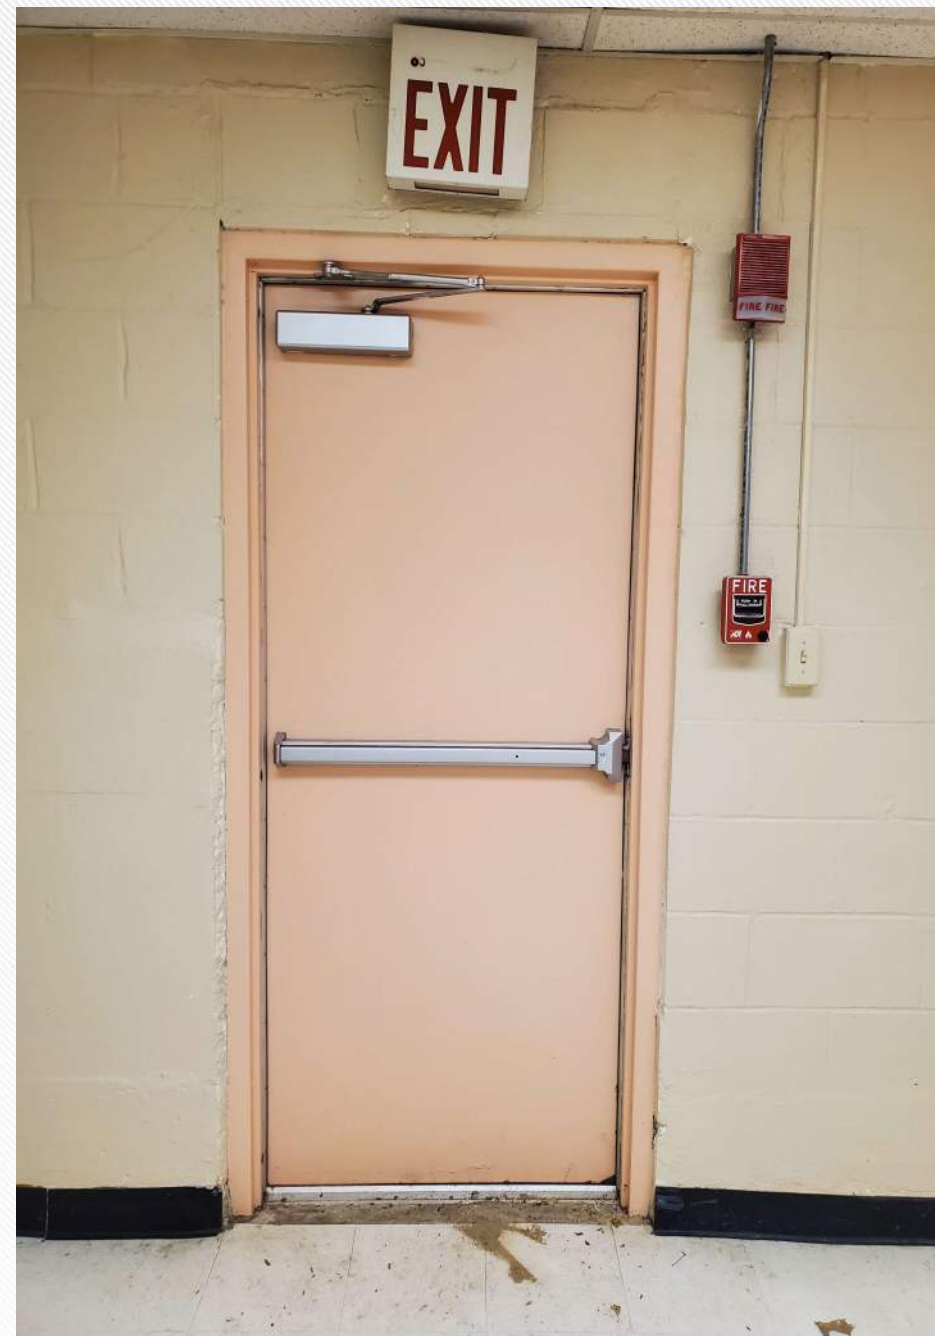
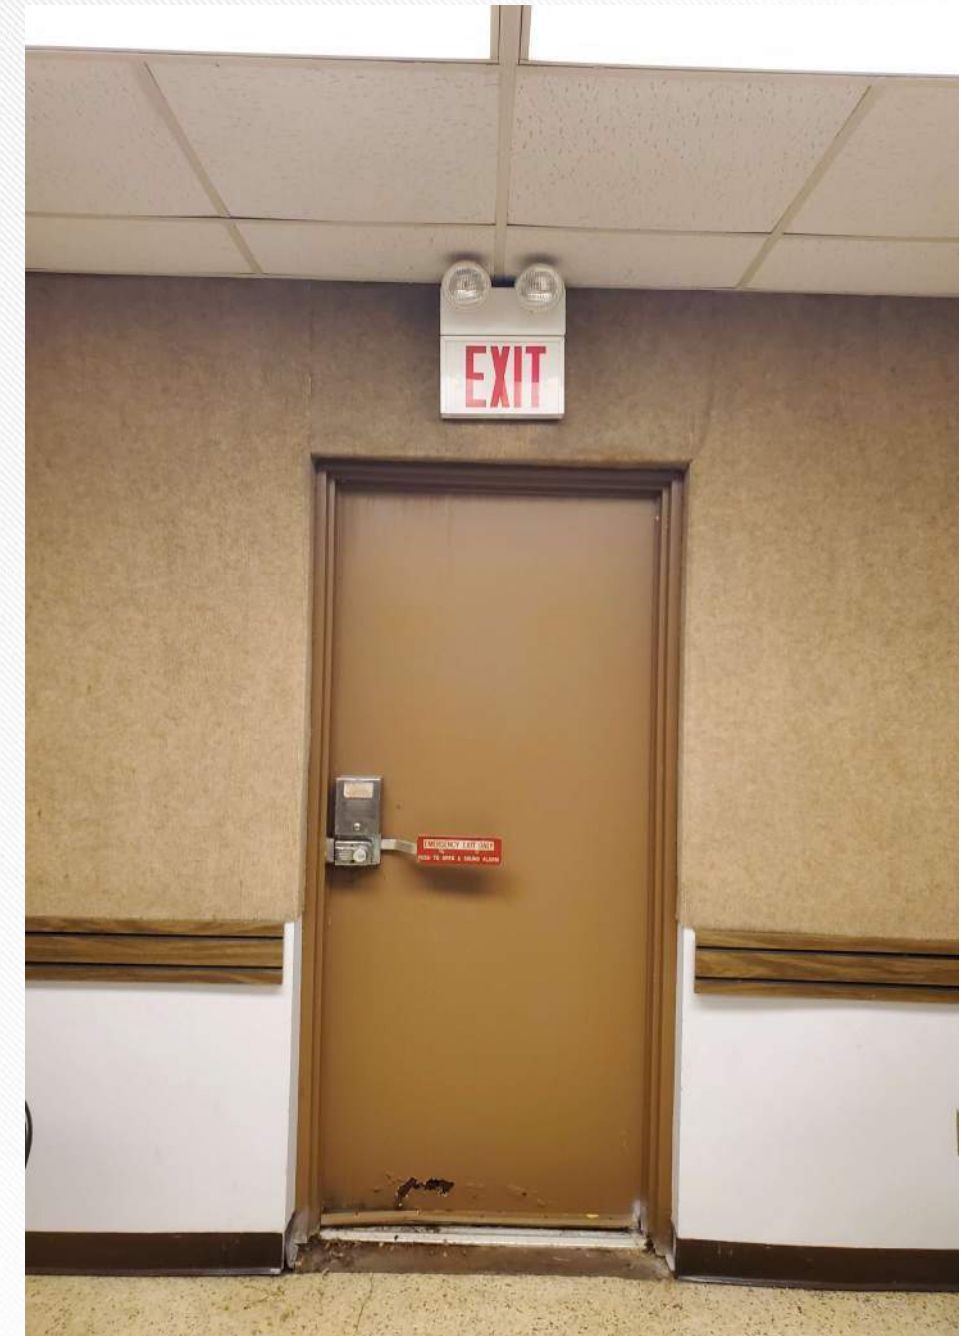
- Although all exits have Exit signs above doors, the signs have a variety of inconsistent conditions. Some battery backup units are not working as required by building code.
- Emergency panic alarm door annunciation on the illustrated door is not working.

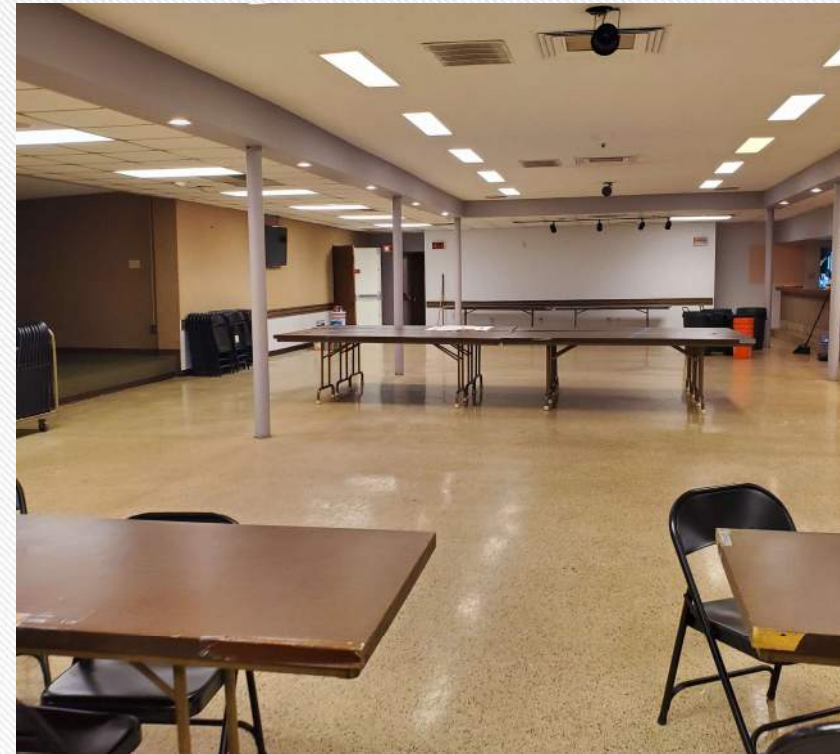
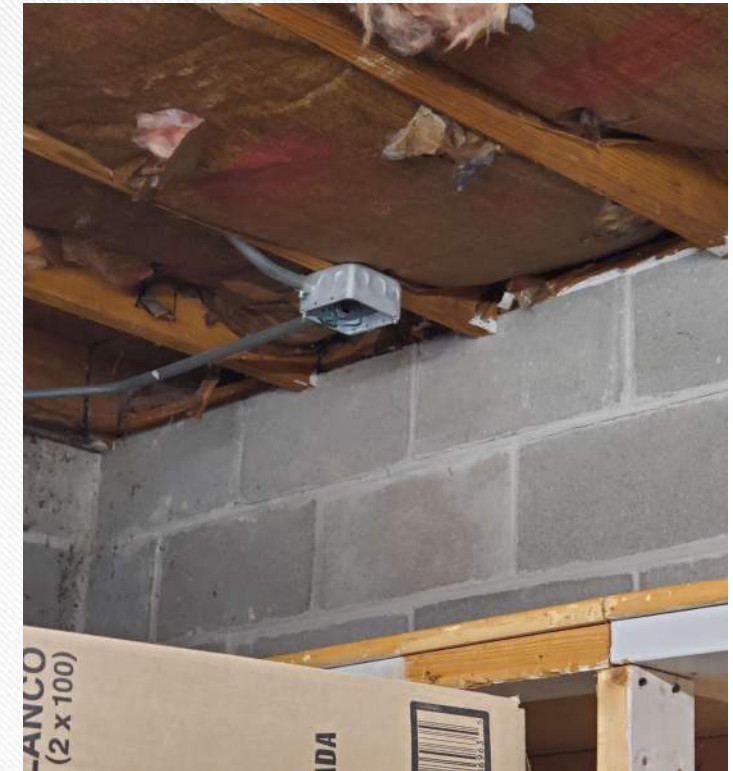
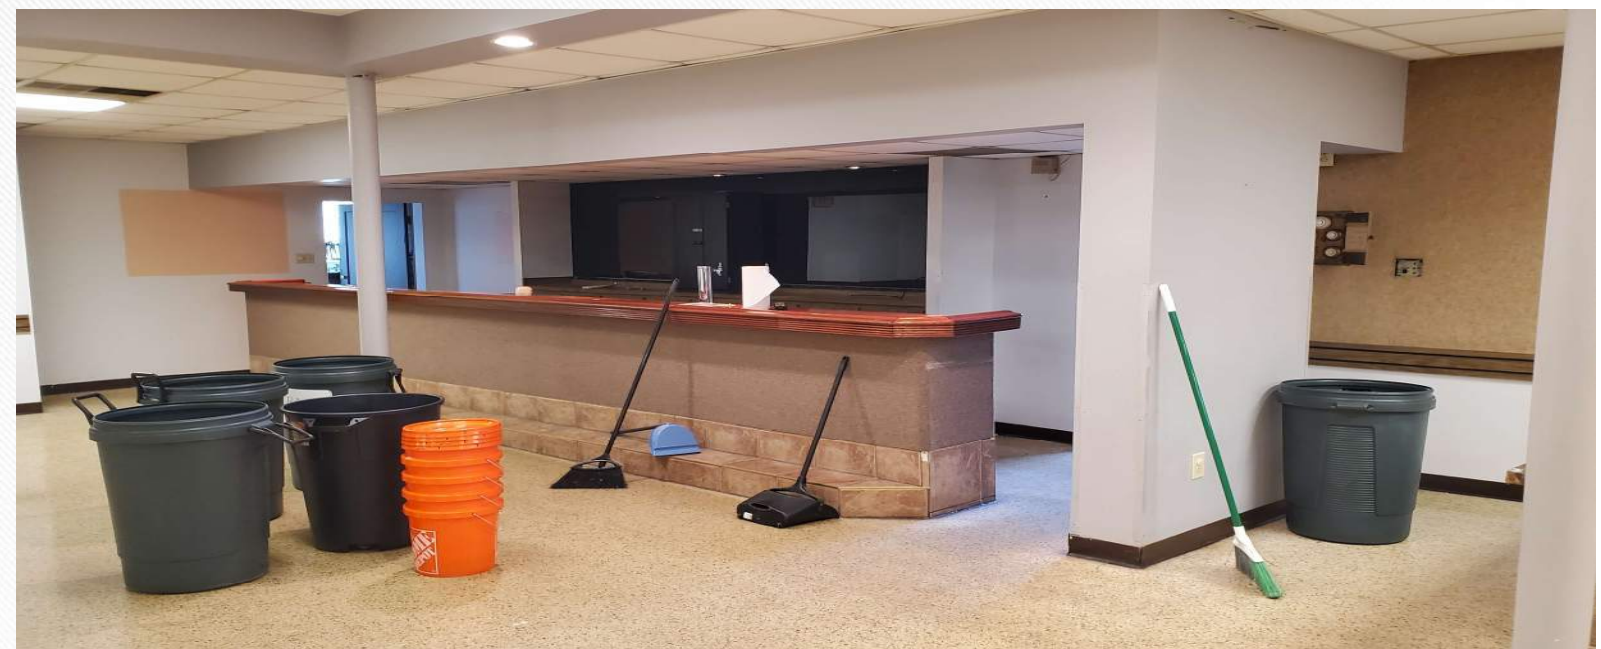
- Acoustical ceiling tiles (ACT) are found throughout the finished spaces. ACT tiles are sagging and stained. Some raised areas have a painted gypsum board ceiling finish.
- Evidence of roof leaks appears in a couple of storage and HVAC spaces. Open junction boxes are found in storage spaces, covers should be installed.
- Exposed kraft faced fiberglass batt insulation is installed in ceiling joists. Kraft faced batt insulation should not be left exposed as it does not have a fire rating.

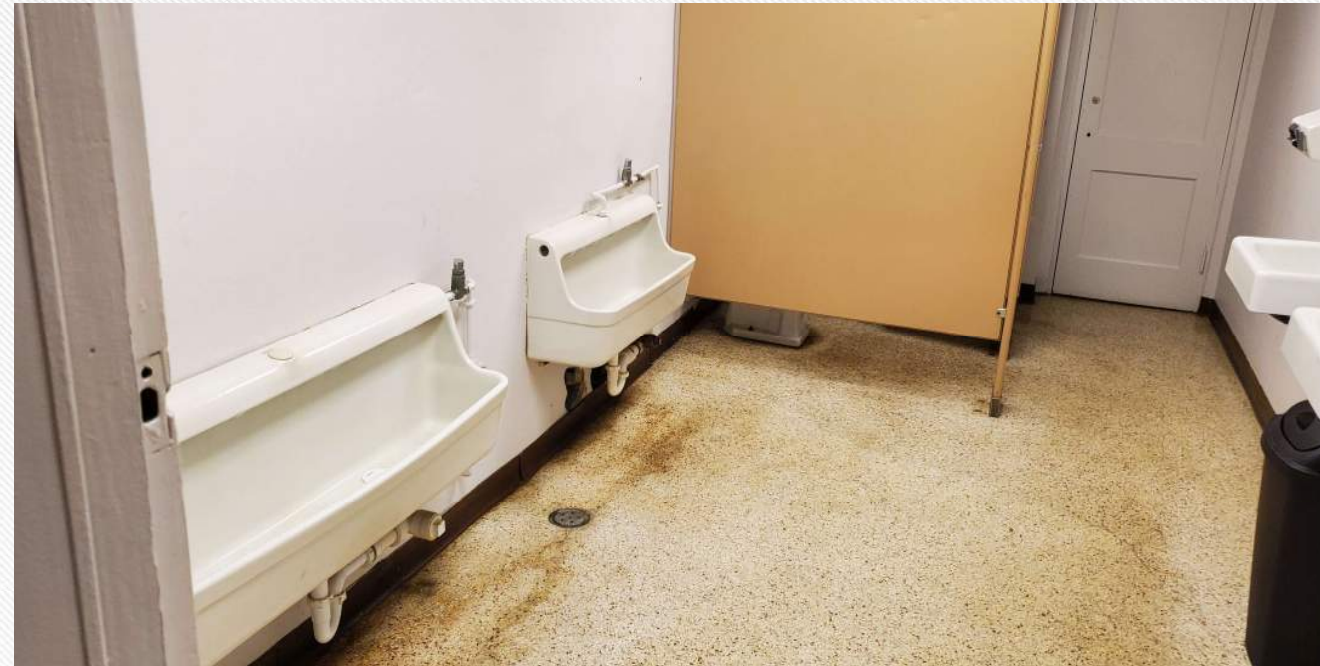
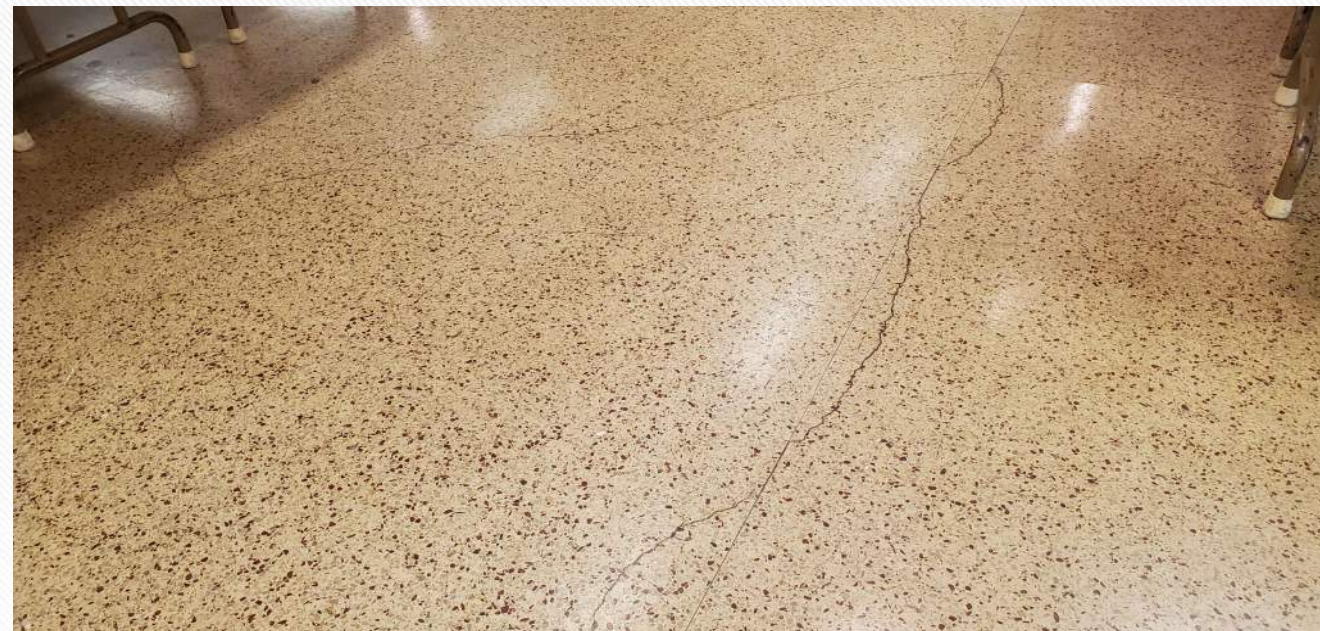
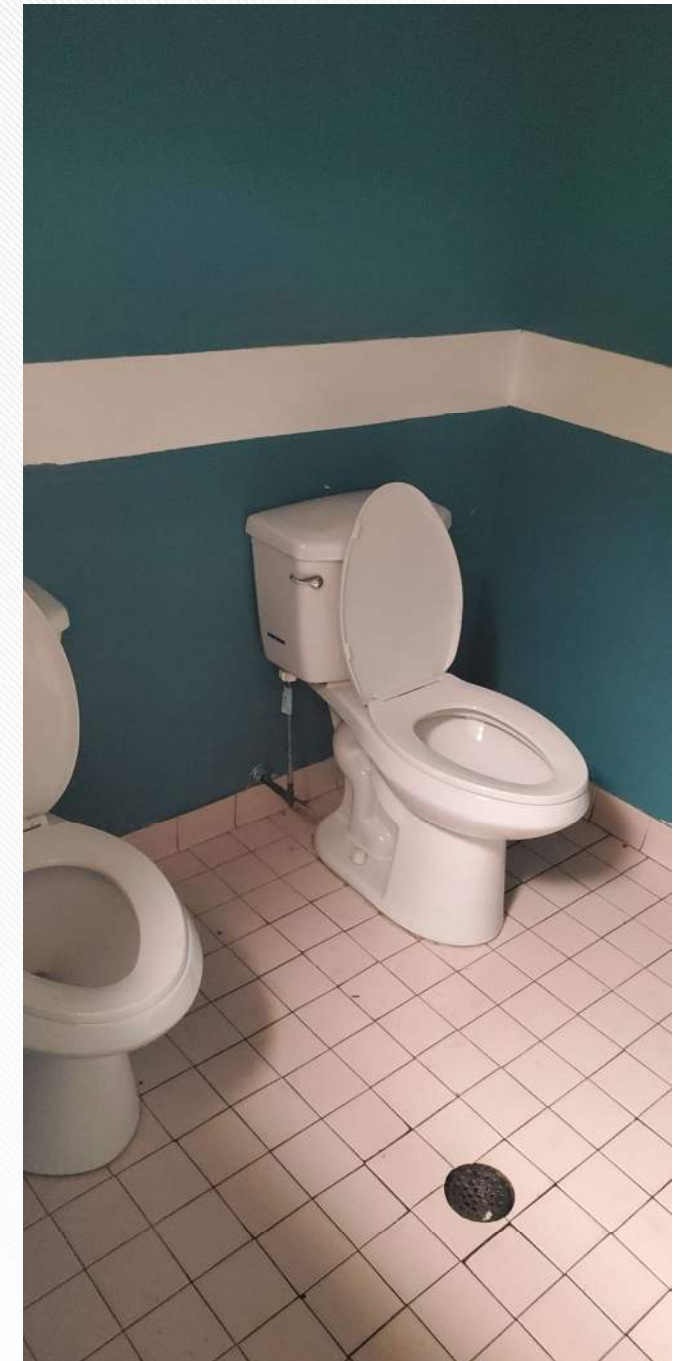
- Main Entry space and Toilet Room flooring is terrazzo flooring over concrete slab on grade. Terrazzo floor is cracked and delaminating. Staining and discoloration is evident
- Other spaces are Vinyl Composite Tile over 20 years old.
- Some secondary Toilet Rooms have residential 4x4 glazed ceramic tile flooring.

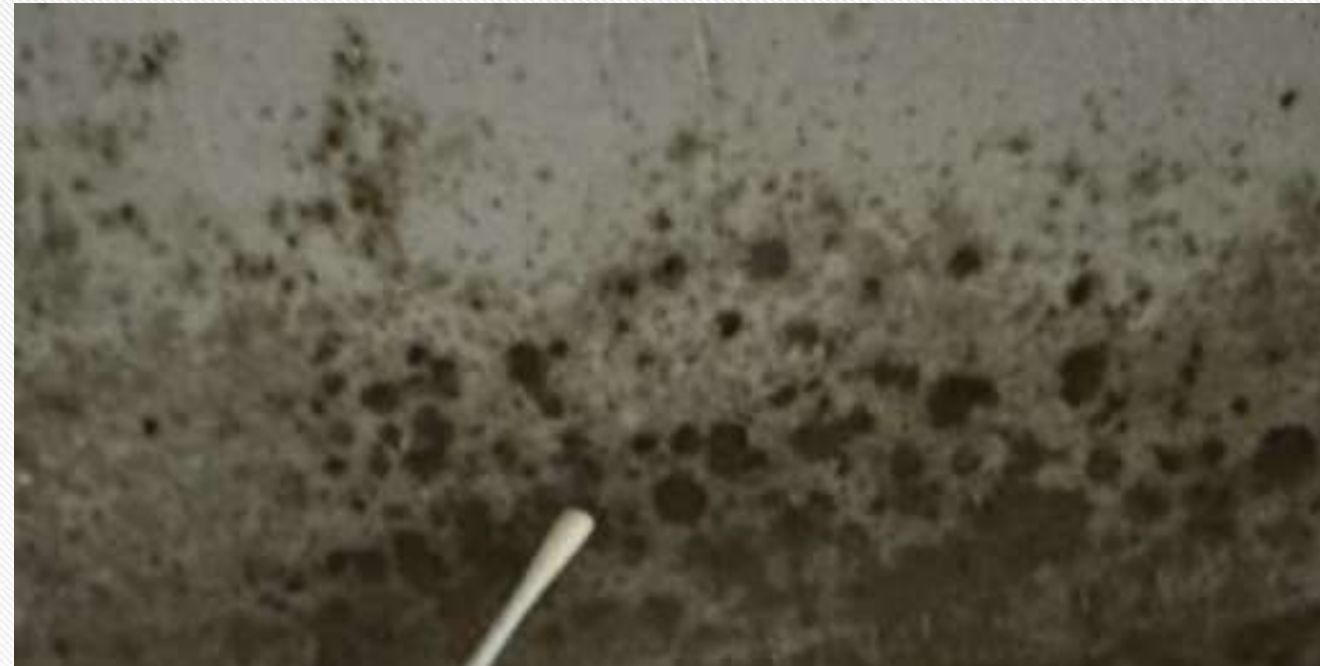
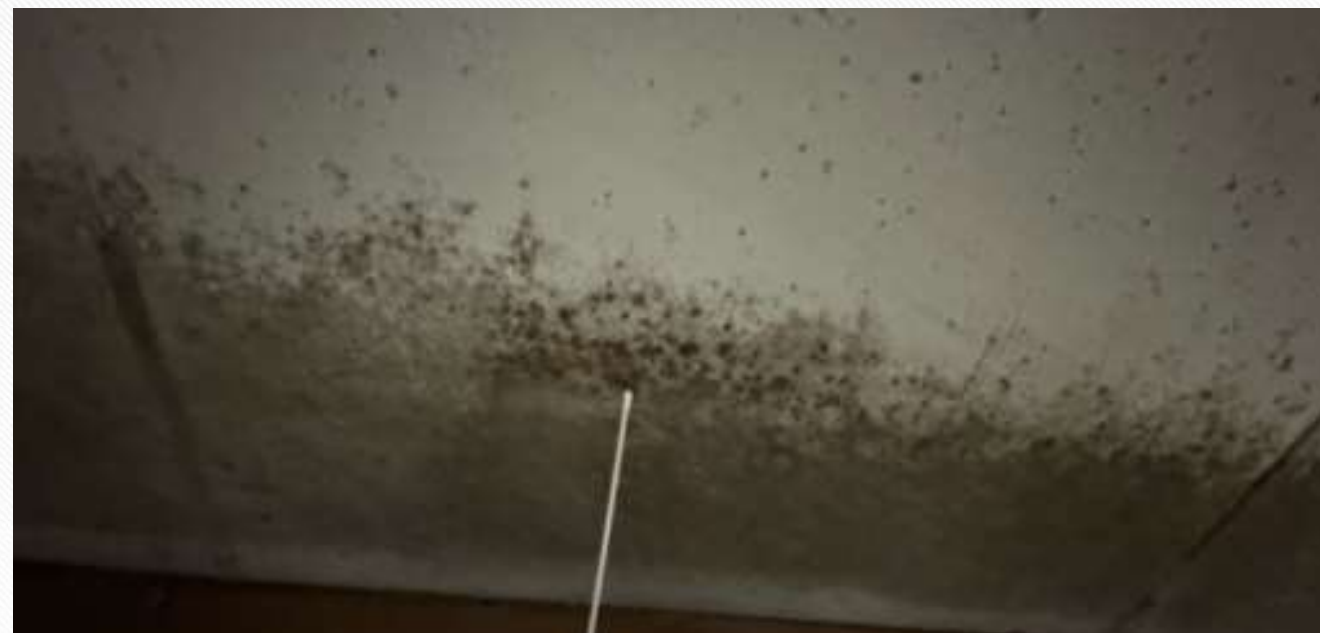
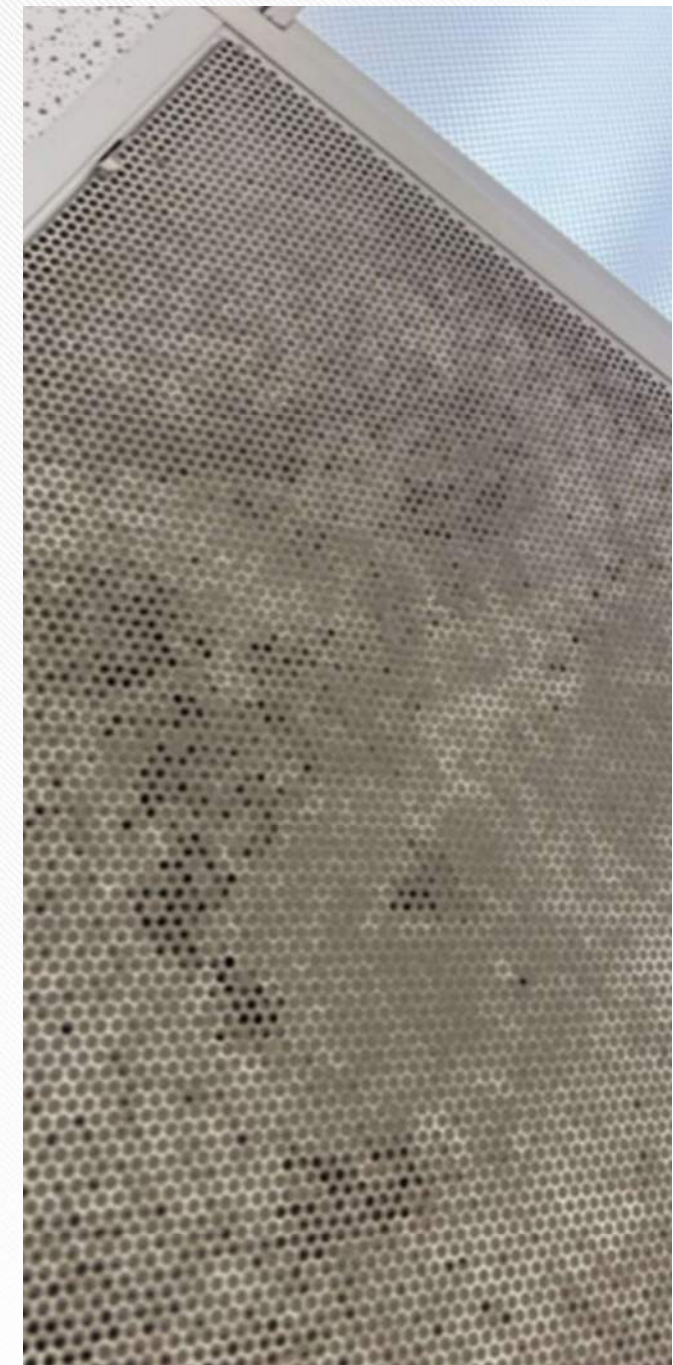
- Inspection for mold has been performed at the facility and suspect surfaces were sampled and laboratory tested.
- East and Main Rooms were tested for mold. Airborne Penicillium / Aspergillus was detected (spore counts: 1,200 / 3,000+).
- High levels (spore count: 10,000+) of Cladosporium was detected on the North walls and spaces. Cladosporium is a [genus](#) of [fungi](#) including some of the most common indoor and outdoor [molds](#). Some species are [endophytes](#) or plant pathogens, while others [parasitize](#) fungi.
- Mold conditions do exist and professional mold remediation is recommended.

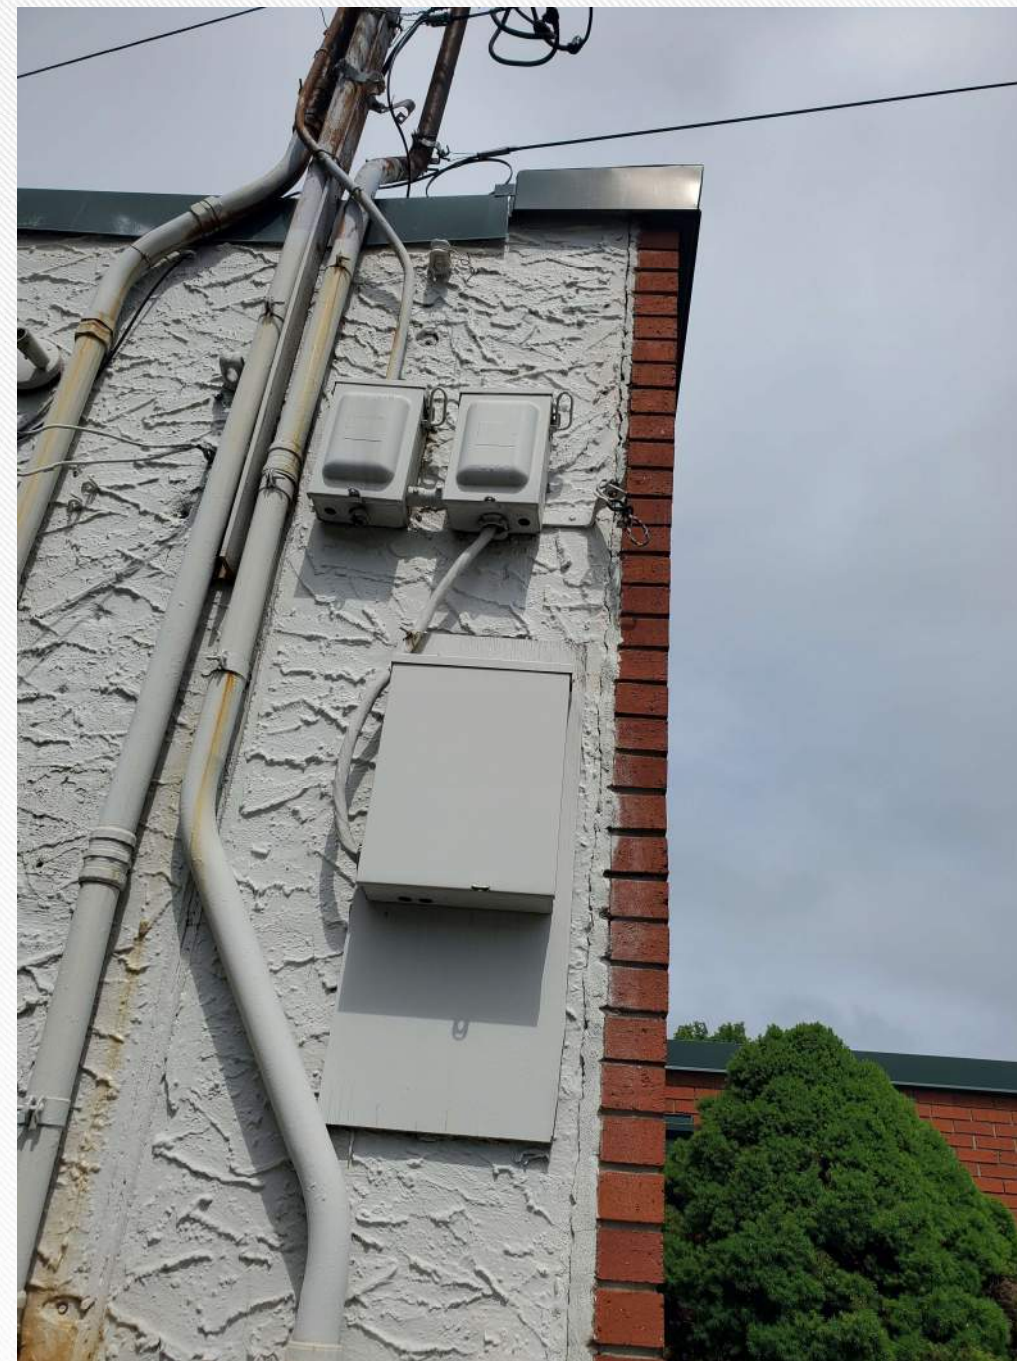
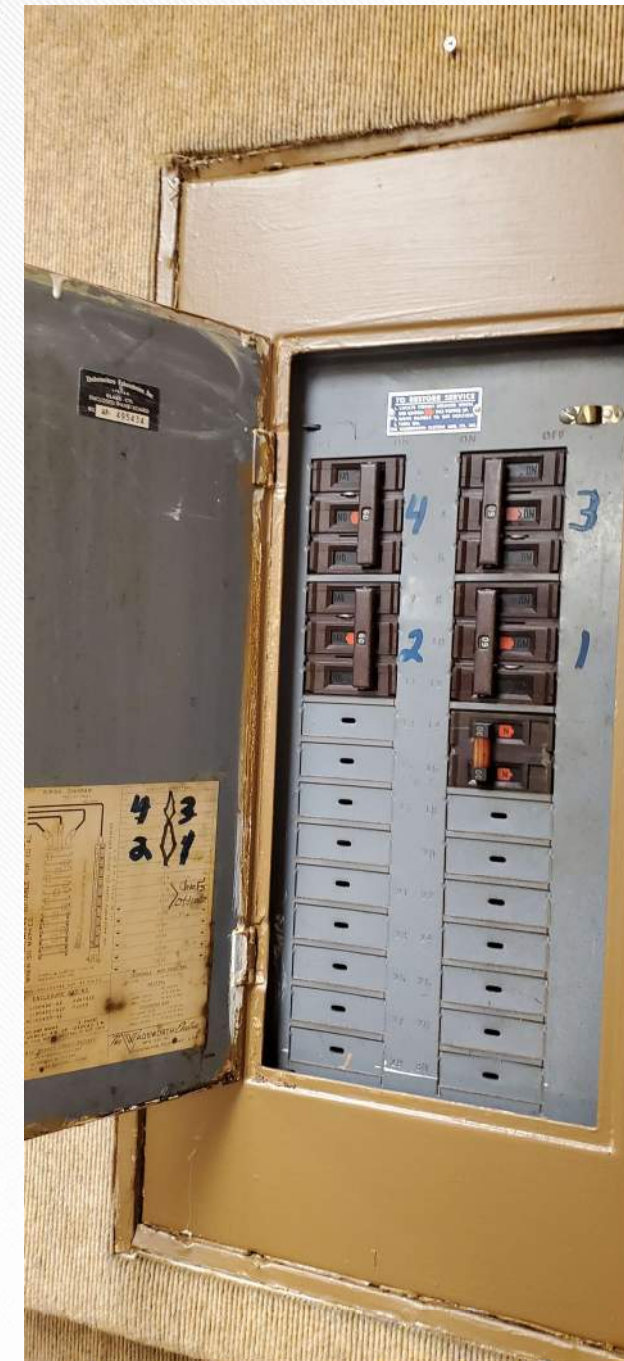
- Electrical service terminates at Wadsworth switchboards. Branch panelboards are installed recessed in finished and concealed areas which makes adding new circuits difficult. Typical life expectancy for distribution equipment is 30-40 years.
- Access to replacement parts, if not already will soon be difficult. Almost all equipment is manufactured by Wadsworth or Westinghouse, which no longer produces electrical distribution equipment.
- Signs of age in the general power infrastructure of the building need to be addressed but all are typical for a building of this age. It's likely that given the age of the building that branch circuit conductors that are installed in the existing walls are past their useful life.

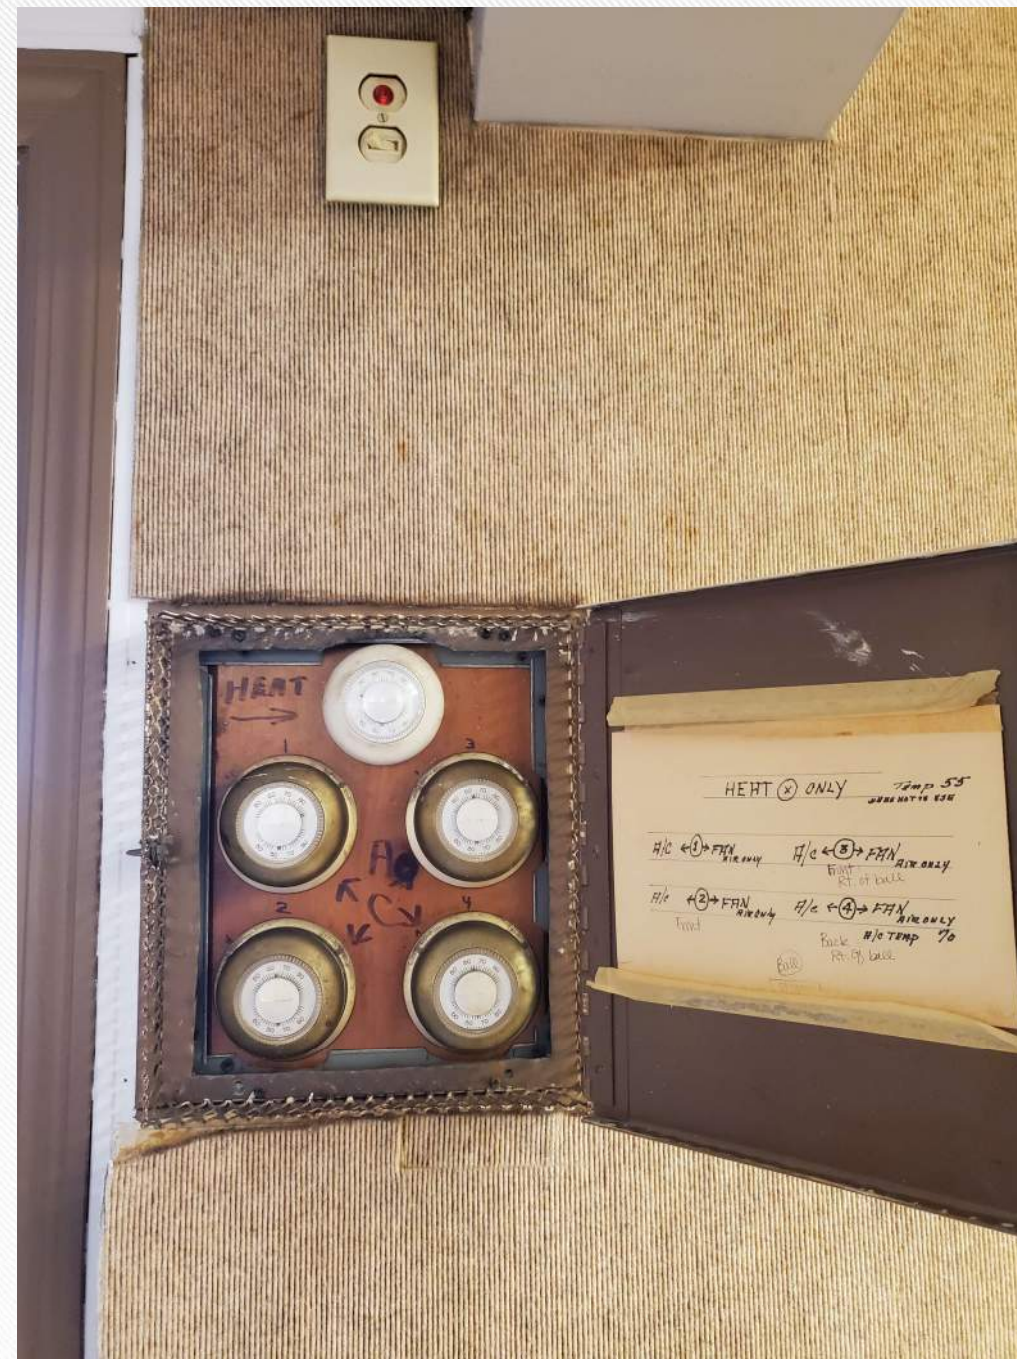
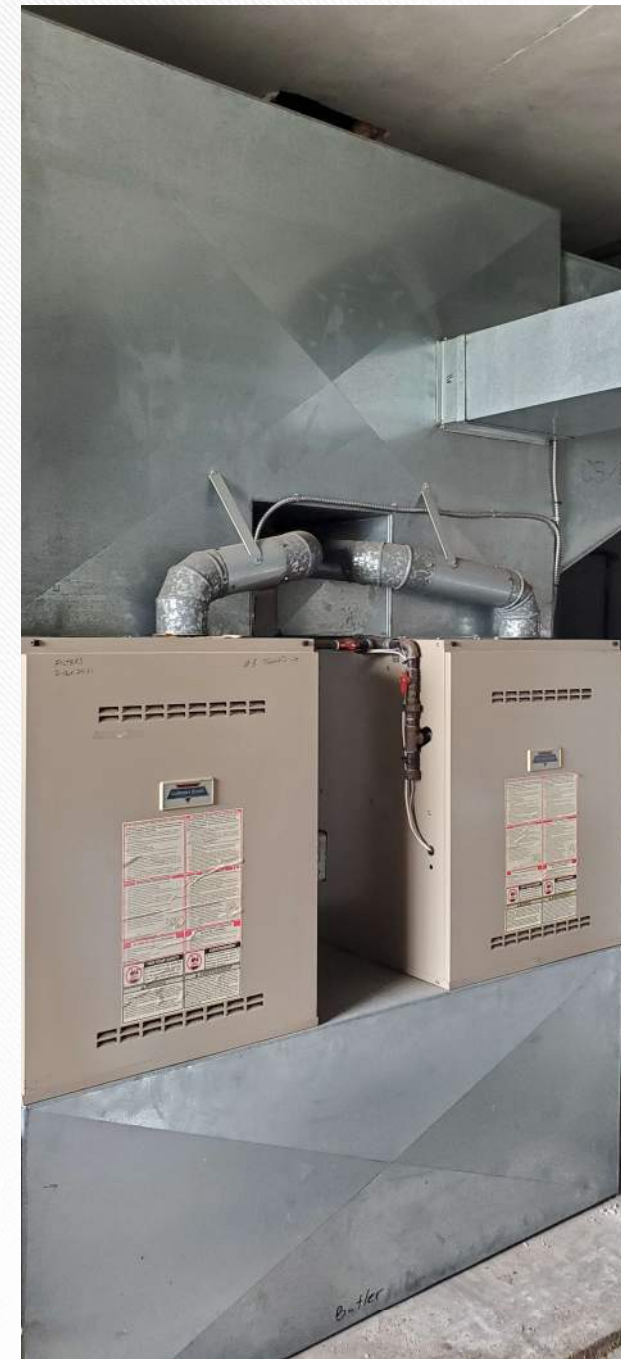
- The HVAC systems consists of central split system air handlers with electrical heat. Supply is ducted to supply grilles within each space. The method of return to the air handlers is eggcrate grills and ducted returns in each space.

- Temperature controls are simple residential Honeywell manual thermostats.
- Larger spaces do not have the required air volume changes for assembly uses and do not have necessary fresh air for ASHRAE 90.1 requirements.

- Supply ductwork at the unit connections did not appear adequately sealed. It did not appear that all supply ductwork was insulated.
- The indoor air handlers are nearing the end of life and should be replaced. Current energy codes may require air side economizers be added to the units based on the size of the equipment if changes to the building occur.

- The Rooftop units (East and West) are approaching the end of their useful life (15-20 years) according to ASHRAE guidelines. They use older refrigerants and need to be replaced

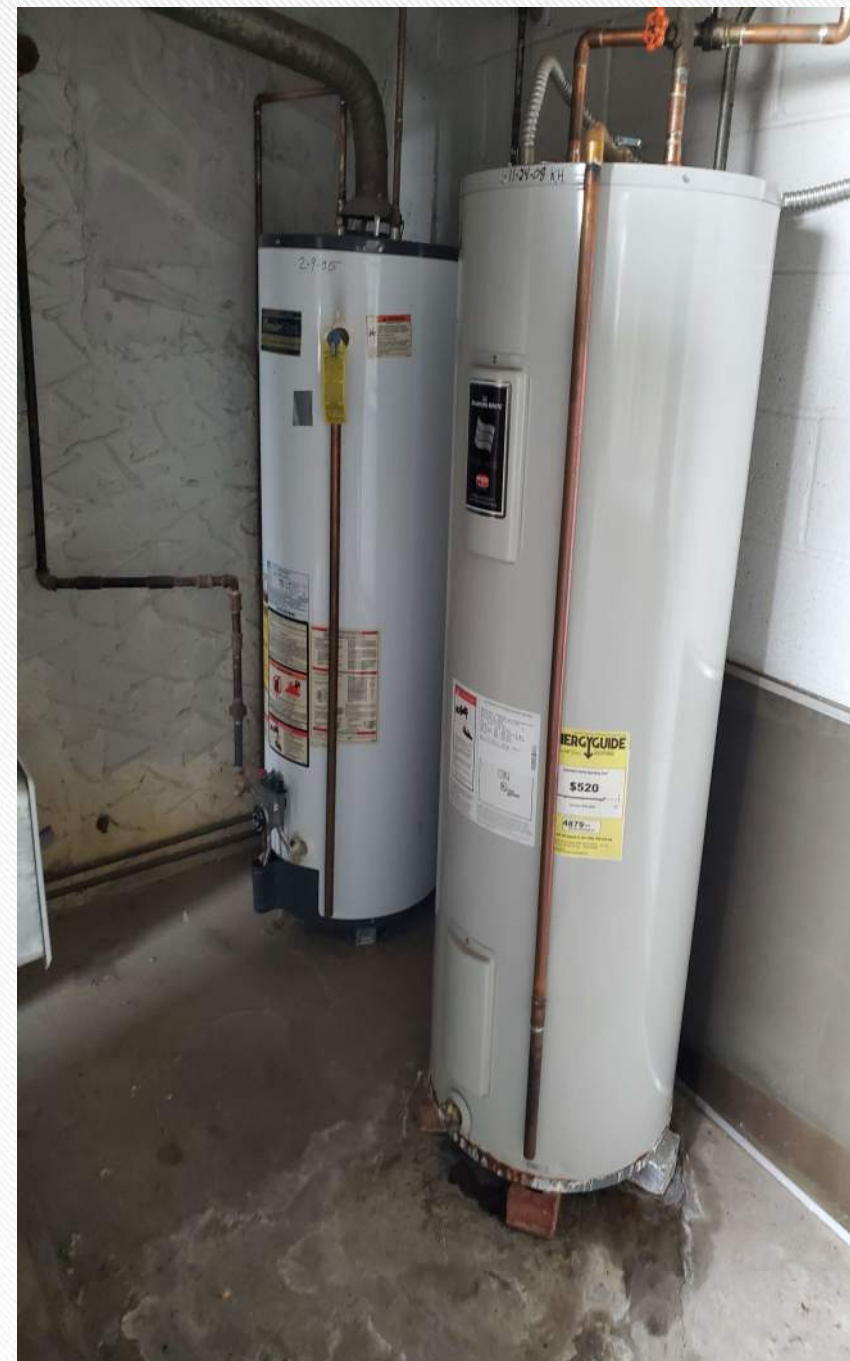
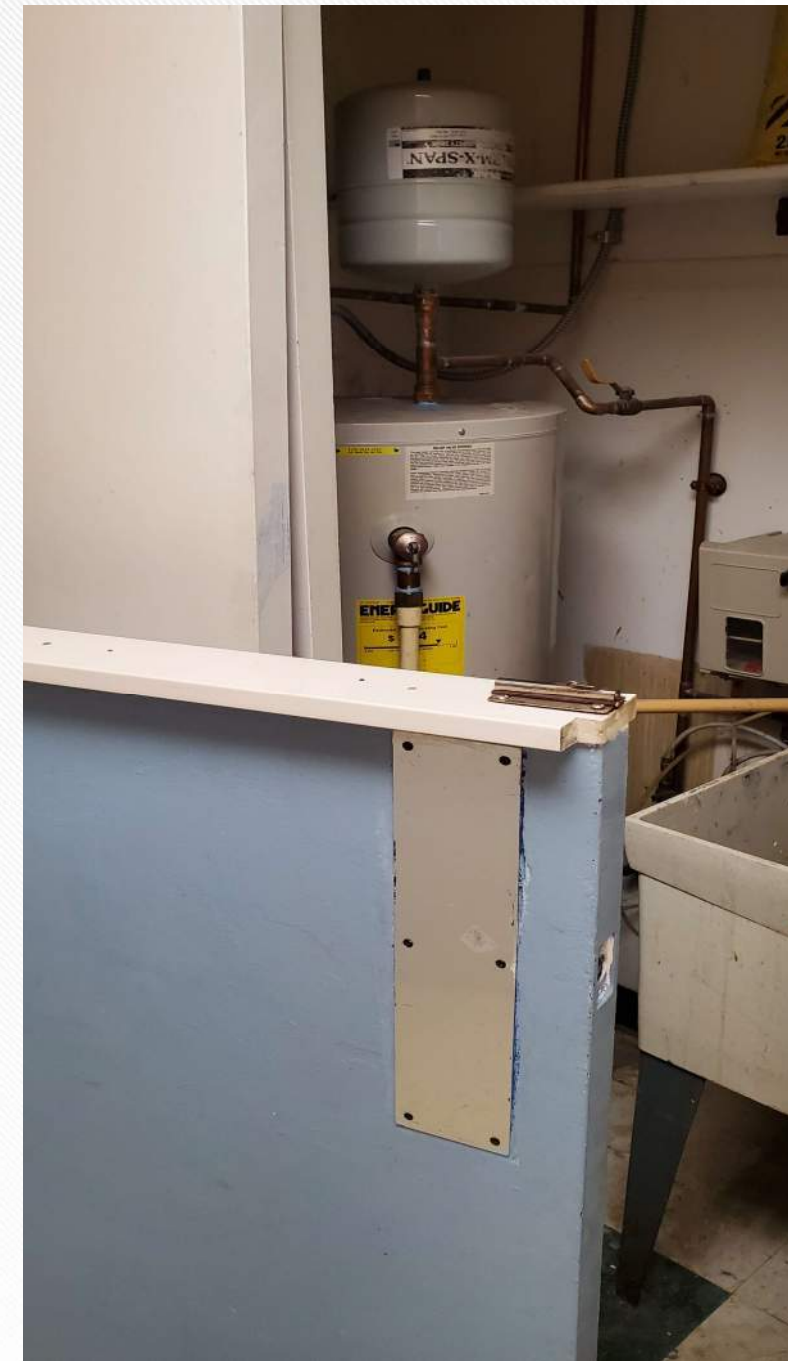
- There are multiple tank-type electric and gas water heaters located near the toilet rooms and janitor closets. Heaters are of variety of manufacturers, most are 40 and 50 gallon units, some with expansion tanks.
- Install dates were noted as ranging between 2005 and 2008. Water heaters should be replaced every 20 years.
- There were no hot water return pumps on any of the water heaters.
- These heaters appear to be in serviceable condition but are on the edge of their useful life.
