Client Name: City of Fort Wright  
Inspector: Cincinnati OH, - Chris Fleming  
Location Address: 115 Kennedy Rd, Covington, Kentucky, 41011  
Inspection Date: 05/20/2024  
Time of Inspection: 12:00 PM

## Basic Mold Inspection Report

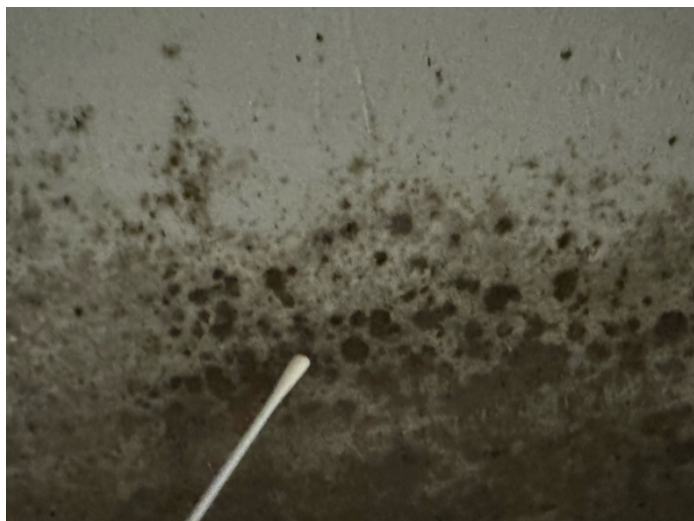
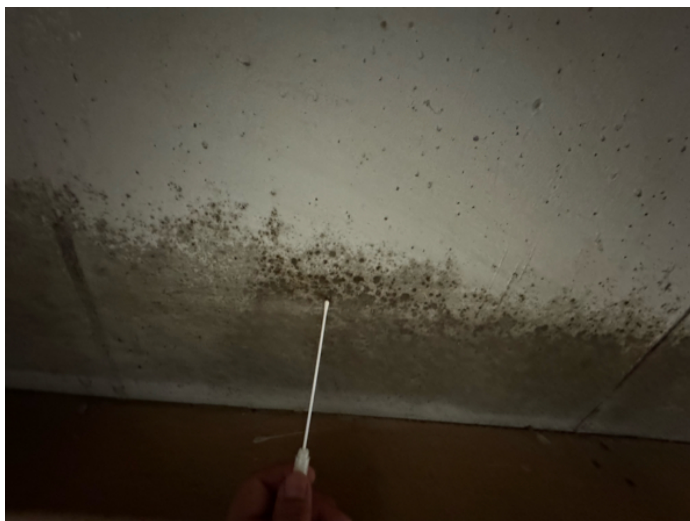
**Sample ID:** 1

The north wall tested elevated for Cladosporium.. This sample tested high, the high range starts off at 10,000.

**Area Tested:** North Wall

Remove all contaminated drywall/insulation 12" past any visible mold. Clean and treat structural components and wipe down all vertical/horizontal surfaces with anti-microbial, HEPA vac and run air scrubbers for 48-72 hours throughout work. MI&T recommends clearance testing before rebuild process begins to ensure work has been completed properly.

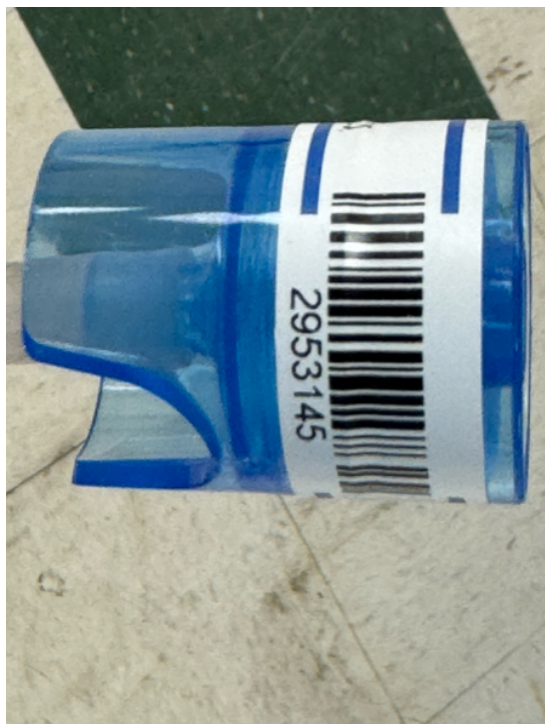
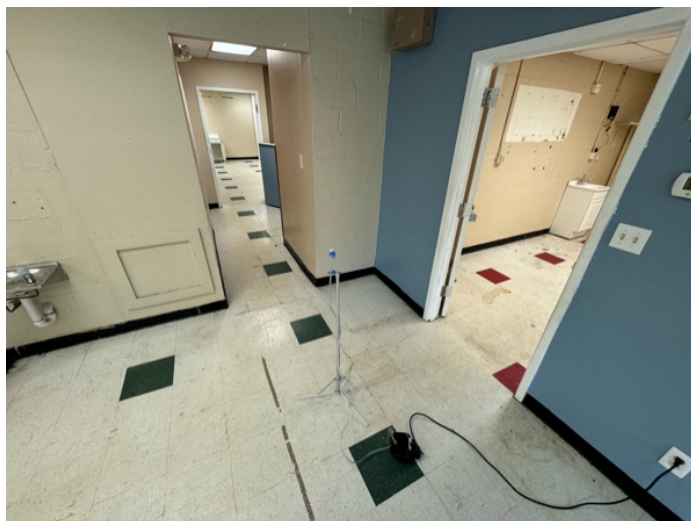
**Sample ID:** 2953145

**Areas of Concern:** The east and main rooms tested elevated for Penicillium / Aspergillus. Elevated levels are over a spore count of 1,000. The east room was 3,000, the main room was 1,200.

**Area Tested:** East Room

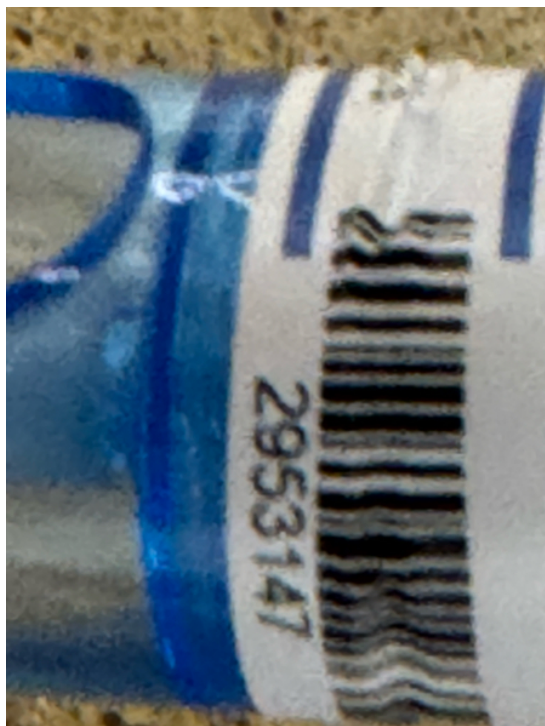
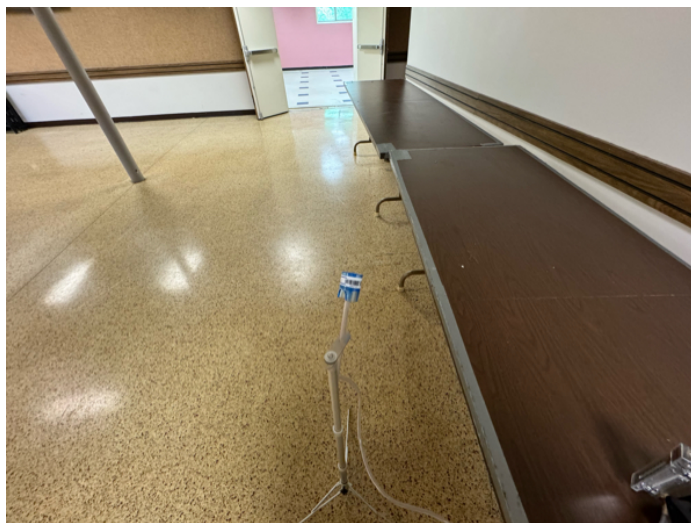
**Sample ID:** 2953147

**Area Tested:** Main Room

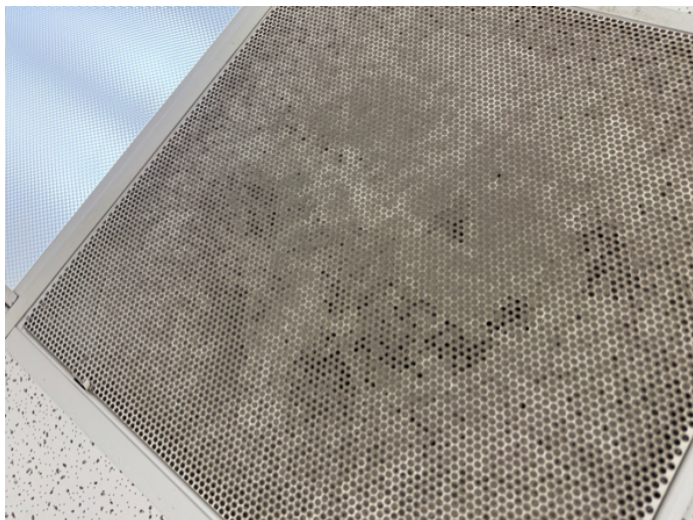
Evidence of roof leaking.

**Source of Mold Growth:** Roof Leaks

It is imperative that any source of water intrusion be addressed to ensure mold growth does not return.

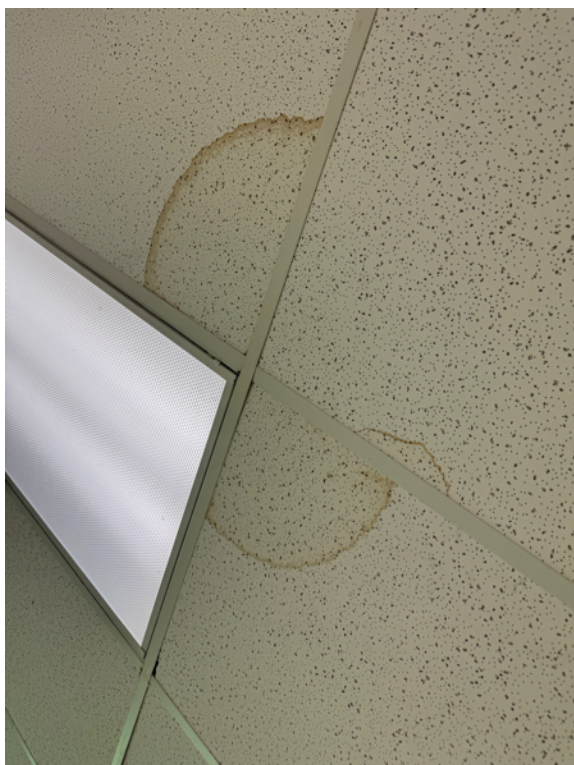
Evidence of roof leaking.

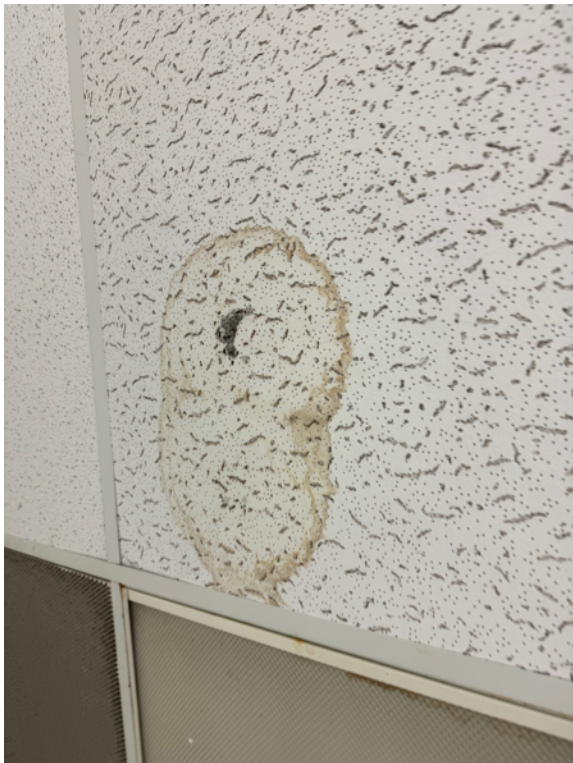
Evidence of roof leaking.
